Downtown Historic District Design Guidelines City of Freeport, Texas

Prepared by Post Oak Preservation Solutions &
University of Texas at San Antonio Center for Urban and Regional Planning Research
October 17, 2024

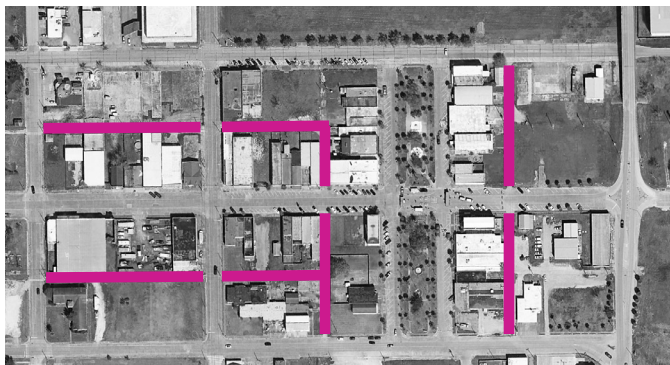
Figure 2.1 | A combination of paved and unpaved alleys provide service access to buildings

- Alleys are behind the buildings along W. and S. Park Ave., accessible via 2nd St., Broad St., and 4th St.. Alleys are also present behind buildings that face Broad St. and connect with the Park Ave. alleys near the center of the blocks.

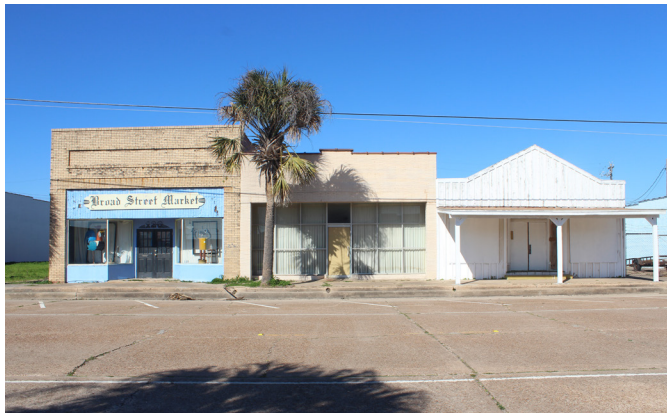
Figure 2.2 | Most downtown buildings adhere to a uniform setback

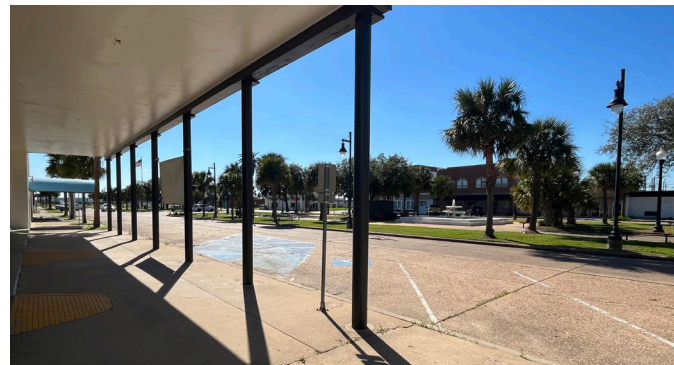
Figure 2.3 | Awnings are interspersed throughout downtown, providing shade for pedestrians

- Several of the buildings on the north end of E. Park Ave. feature awnings that extend over the sidewalk.
- Sidewalks line all of the primary commercial streets in the district except for E. 4th St., where sidewalks are intermittent.
- The park between W. and E. Park Ave. provides a comfortable, shaded place for pedestrians to rest, with ample seating throughout.
- Palm trees have been planted intermittently along W.

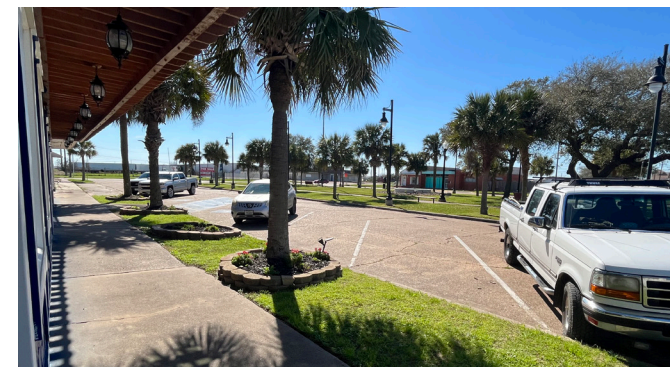
Figure 2.5 | Some areas of downtown feature a grassy median between the sidewalk and the street

- With the exception of Memorial Park (discussed below), the district's landscaping primarily consists of palm trees planted along the sidewalks of W. and E. Park Ave. and Broad St. Grassy medians are present between the sidewalks and the street along W. and E. Park Ave.
- Grass covers most vacant lots within the district.

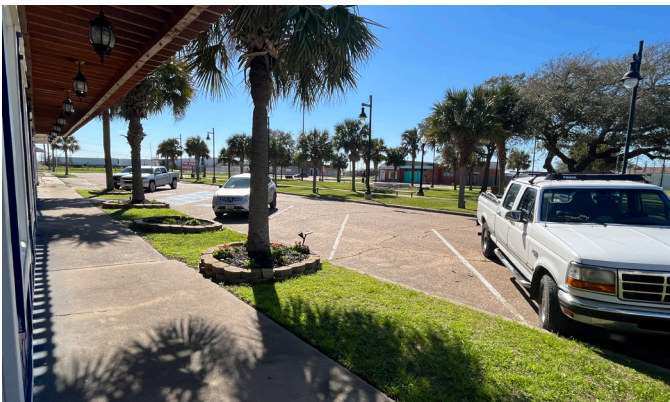
Figure 2.10 | W Park Ave and E Park Ave features angled street parking

- Angled, on-street parking is located along 2nd St., W. and E. Park Ave., and Broad St.

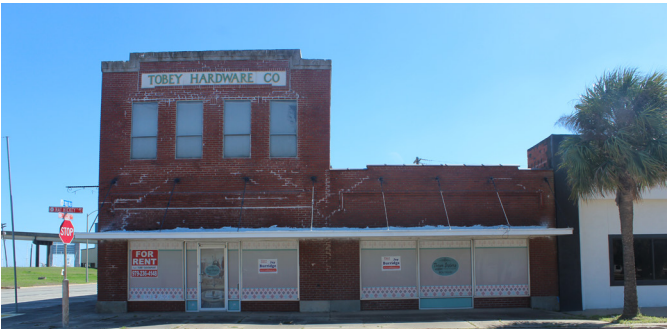
Figure 2.11 | One-story and two-story masonry buildings are a common throughout downtown Freeport

Most building types in the Downtown Historic District share a basic one- or two-story box-like form. They are generally rectangular in plan with load-bearing masonry walls and flat roofs. The first floors of two-story buildings generally have large display windows or storefront systems, while the upper floors have smaller windows. Individual buildings are attached, often sharing party walls.

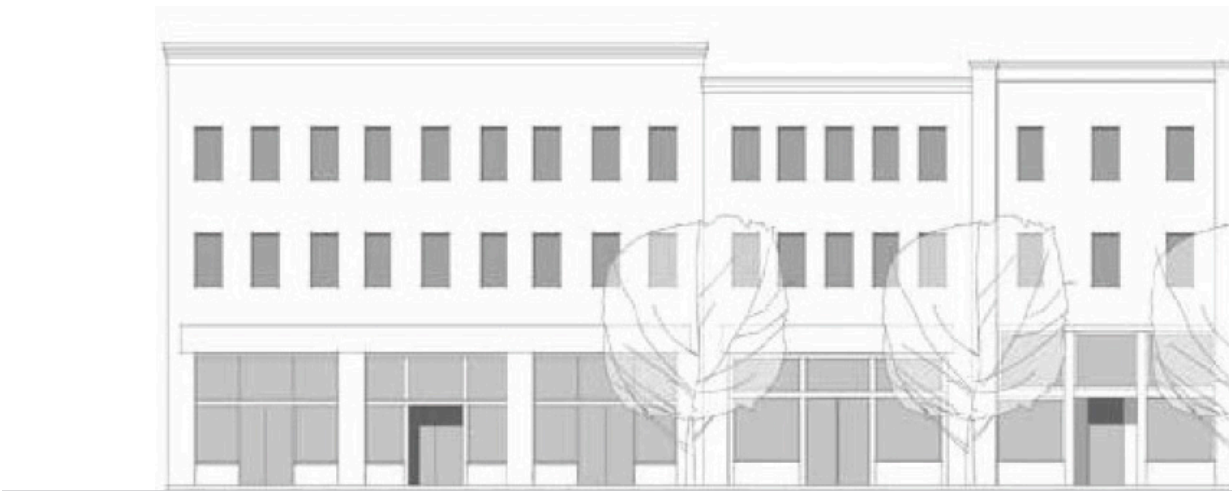
Figure 4.2 | This large commercial building is broken up into smaller modules | Post Oak Preservation Solutions

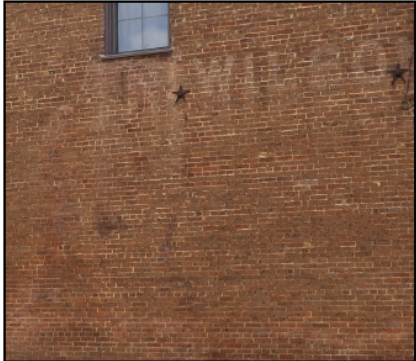
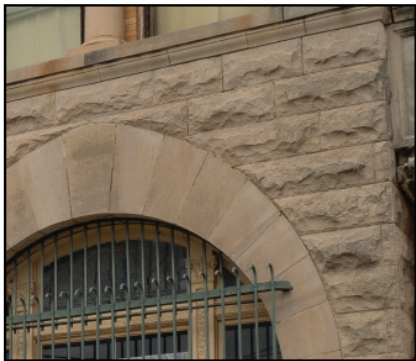
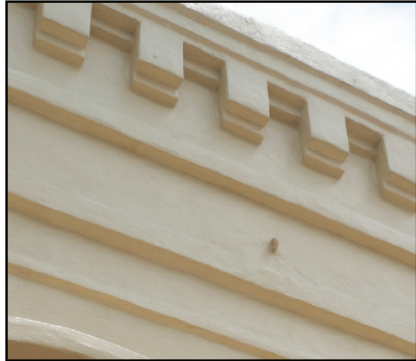
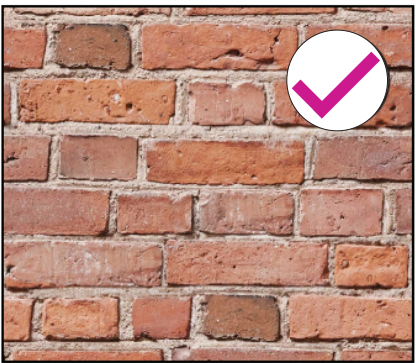
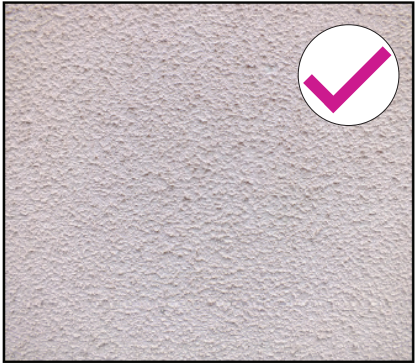
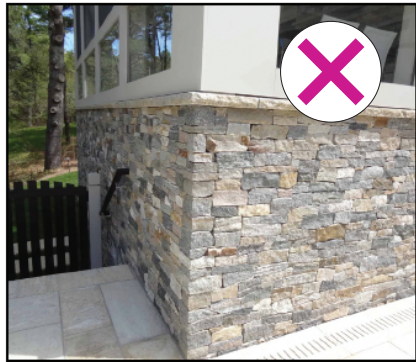
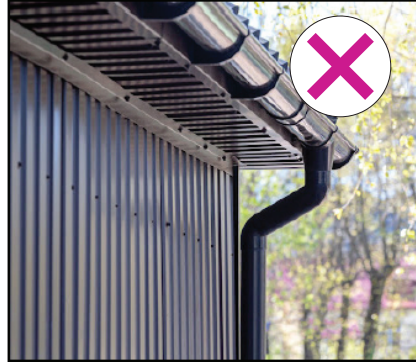
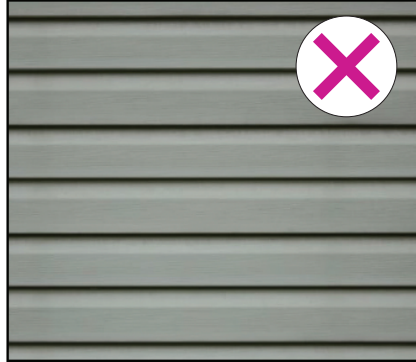
Figure 4.3 | Appropriate & Inappropriate Exterior Building Materials | Post Oak Preservation Solutions

Brick

Stone

Plaster Stucco

Stone Veneer

Metal Siding

Vinyl Siding

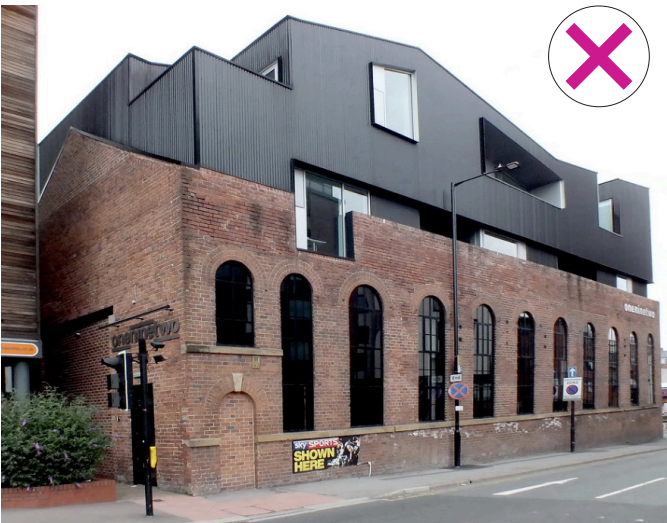
Figure 4.4 | The design of this addition overwhelms the historic building and is not appropriate for the Historic District | Oneninetwo

4.6.4.3. The roofs of additions should not interfere with the original roof form by changing its basic shape and should have a roof form compatible with the original building.

4.6.5. Additions that are not visible from the street or the public right of way have more flexibility with regards to materials, massing, and details and may not need to follow the above guidance as precisely as a visible addition.

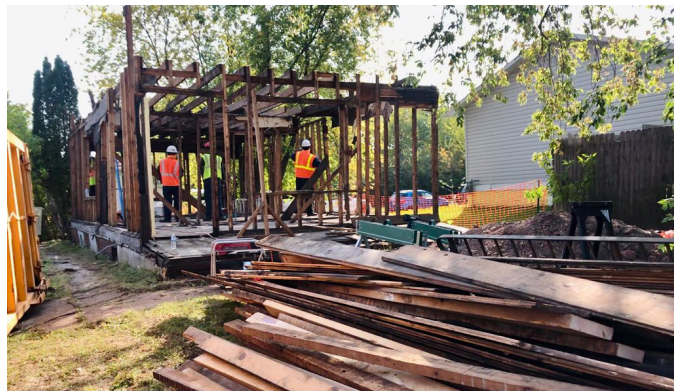
Figure 5.1 | Deconstruction and Relocation techniques | Better Future Minnesota

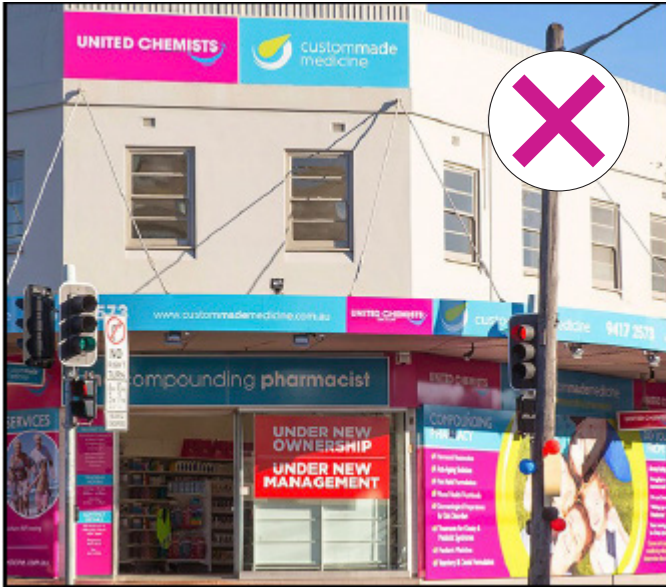
Figure 7.1 | The size, location, and number of signs on this building are inappropriate for a Historic District | Post Oak Preservation Solutions

7.1.1. Each nonresidential structure in the historic district may have up to 5 types of signs in use at any given time. The five sign types are listed below:

- 7.1.1.1. A primary sign represents the owner’s largest sign expense and is likely the most important of the five sign types. Only one primary sign will be allowed per business per building. The primary sign’s audience is specifically the viewer driving past in a vehicle.
- 7.1.1.2. Secondary signs are utilized in addition to

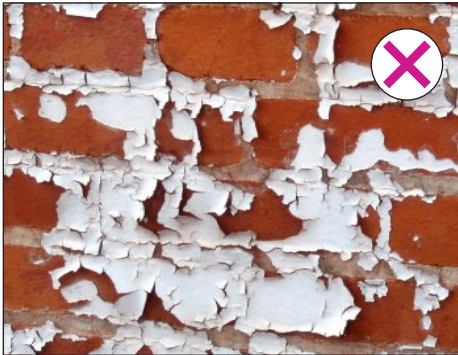
Non-historic paint coatings and water repellent treatments are inappropriate for historic masonry | Post Oak Preservation Solutions

- Cleaning masonry should only be undertaken to stop active deterioration or remove significant soiling. If cleaning is necessary, start with the gentlest means water, typically low-pressure water (like a garden hose) with a soft bristle brush. Any additional cleaning products should be appropriate for historic masonry and should be tested prior to application. Test products in an inconspicuous location and wait to observe any adverse effects (such as change in color, texture, or gloss). Cleaning may not make masonry look “like new.” Avoid abrasive or mechanical cleaning with power washers, wire wheels, or similar tools. See National Park Service Preservation Brief #1 for additional cleaning guidance (see Additional Resources).

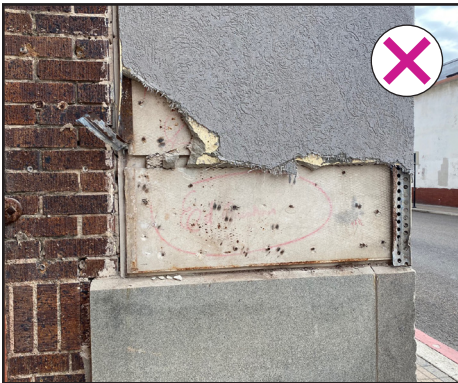
Covering historic masonry can cause damage to the underlying historic material | Post Oak Preservation Solutions

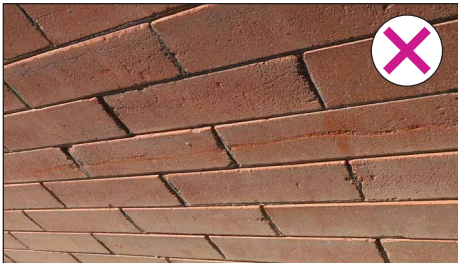
Repoint missing or deteriorated joints with an appropriate, compatible mortar | Post Oak Preservation Solutions

- Repoint missing or deteriorated masonry joints with a mortar that matches the historic in strength, composition, color, and texture, per guidance in National Park Service Preservation Brief #2 (see Additional Resources). It should look the same as the existing mortar and be as soft or softer than original.

- Never use Portland cement to patch or repoint historic masonry as it is too hard and can damage the historic material.
- If any masonry units need to be replaced, the replacement material should match existing historic in size, color, texture, and composition.

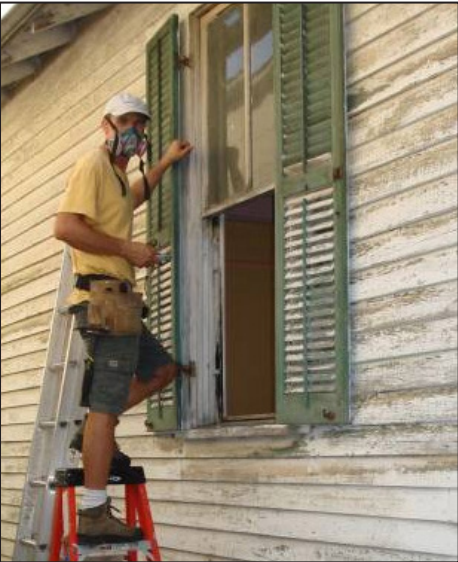
Maintain existing paint coatings on exterior wood to prevent exposure to wind, sun, and rain | Post Oak Preservation Solutions

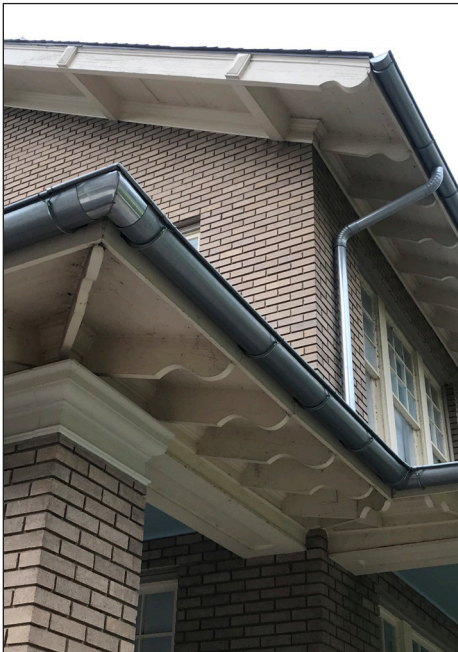
Regularly clean gutters and downspouts | Post Oak Preservation Solutions

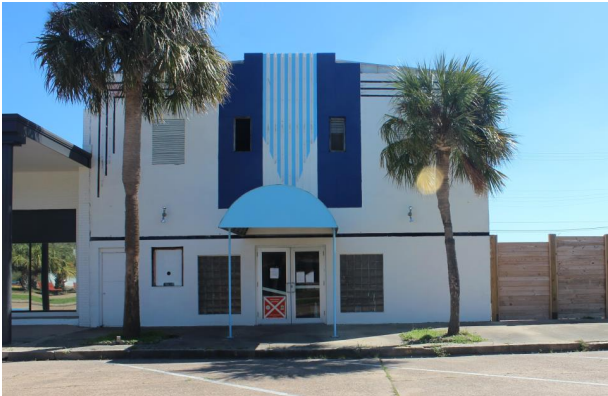
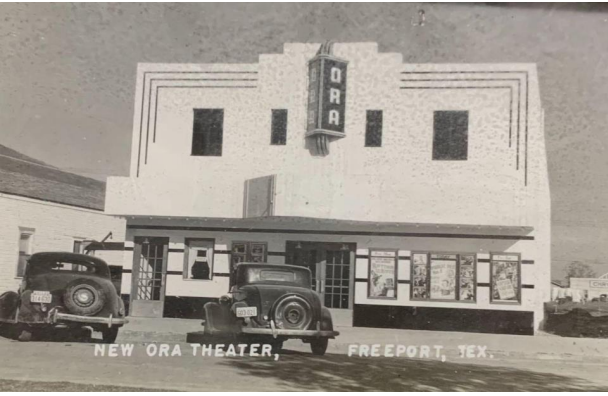
215 E PARK AVENUE
Parcel #: 209224
Year Built: 1940
Style/Form: Art Deco
C/NC: Contributing

Current conditions: First floor openings have been altered to include glass block windows on either side of the entrance and the original marquee and “Ora” signage has been lost. Doors on the primary facade have been replaced.

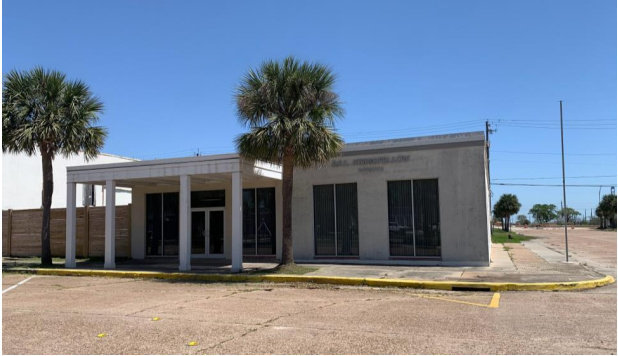
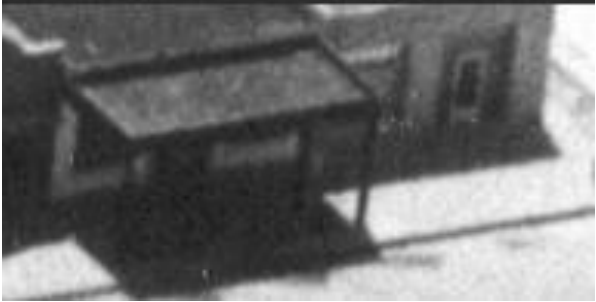
221 E PARK AVENUE
Parcel #: 209219
Year Built: 1931
Style/Form: 1-part commercial block
C/NC: Non-Contributing

Current conditions: The storefronts were combined and reoriented sometime after 1969 to create a single entrance. Stucco was likely applied to the primary elevation at the same time. The awning over the sidewalk dates to the period of significance.

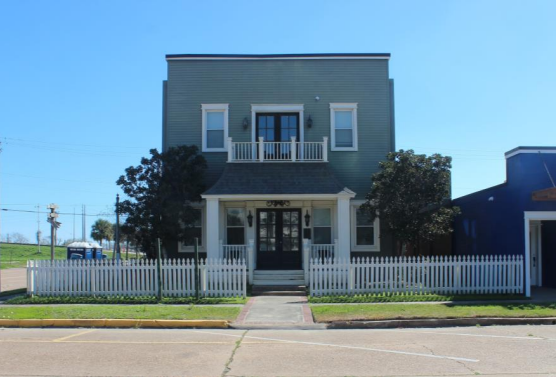
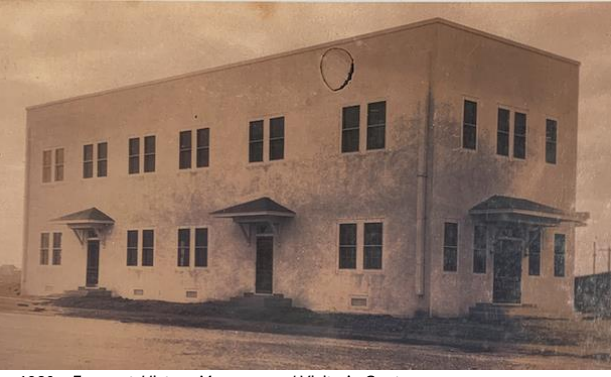
303 E PARK AVENUE
Parcel #: 209237
Year Built: c. 1920
Style/Form: 2-part commercial block
C/NC: Contributing

Current conditions: Wood siding is not historic. New awnings with support columns and second story porches were added to the west and north elevations sometime prior to 2008. Windows have been replaced with compatible replacements.

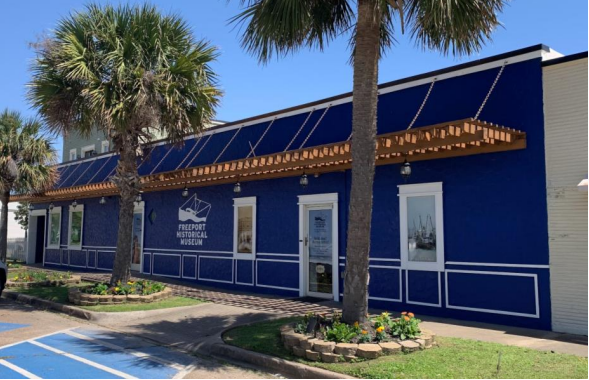
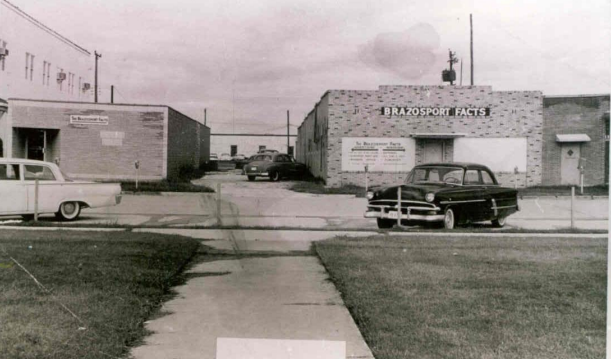
311 E PARK AVENUE
Parcel #: 209236, 638039, 209235
Year Built: c. 1950s
Style/Form: 1-part commercial block
C/NC: Non-Contributing

Current conditions: The primary elevations of historically separate buildings have been heavily altered to present the appearance of a single building. The driveway was enclosed and incorporated into the structure.

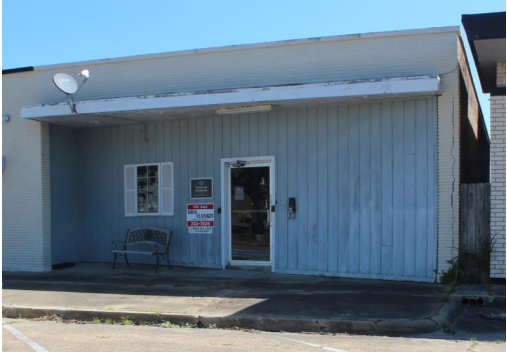
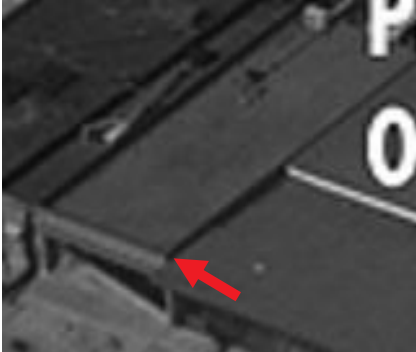
313 E PARK AVENUE
Parcel #: 209234
Year Built: 1952
Style/Form: 1-part commercial block
C/NC: Non-contributing

Historic function: The Houston Lighting & Power Company Freeport office occupied the building from its construction until the late 1960s.
Current function: Vacant
Current conditions: The original storefront has been removed and infilled. Original awning and angled facade have been retained.

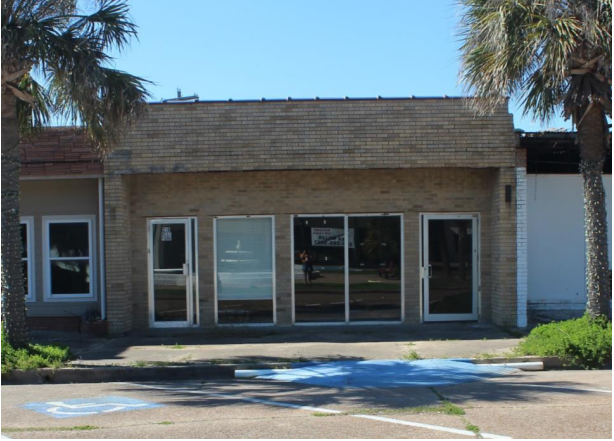
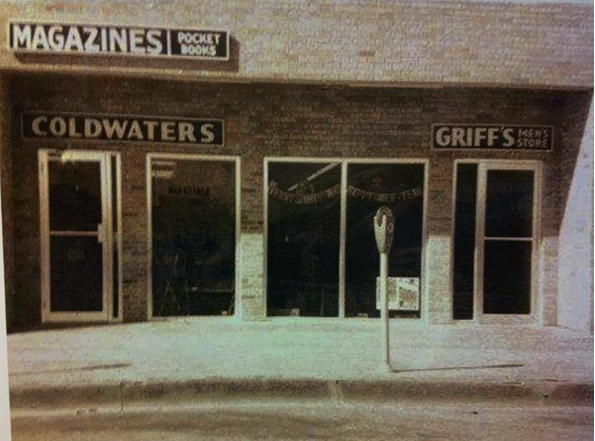
Historic function: Housed the Freeport Office Equipment Company and the Texas Gulf Finance Co. during the 1950s, Loyd Taylor accounting services and Sansom-Davis Insurance Agency during the 1960s.
Current function: Vacant.
Current conditions: Painted brick facade. A portion of the overhanging roofline appears to have been partially lost, which provided a sheltered, recessed entrance. Windows are boarded; it is unclear if they are intact beneath. If the historic windows remain and were restored, this building could be changed to a contributing building.

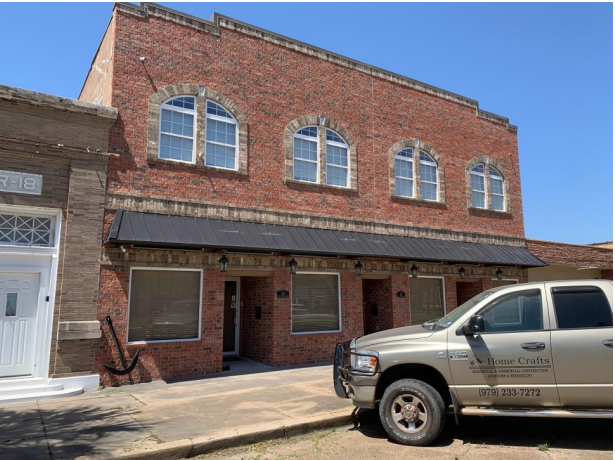
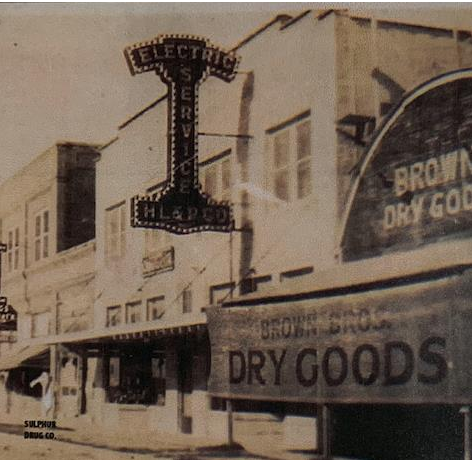
Historic function: Western Auto Supply occupied the building from its construction through the late 1960s.
Current function: Vacant
Current conditions: Historic storefront has been replaced with non-historic infill, though retains roman brick parapet and exterior walls.

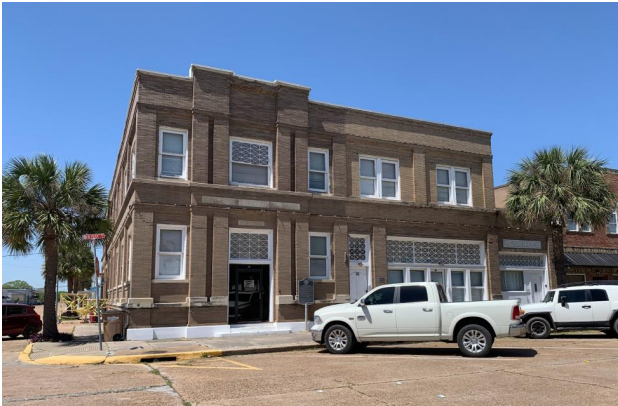
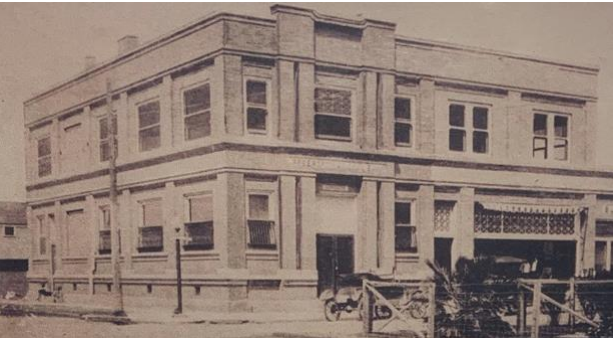
Historic function: Constructed as Baker's Barber Shop. Despite changes in ownership over time it retained the Baker name and housed barber shops well into the 1960s. It was renamed Penney's Barber Shop by 1974.
Current function: Vacant
Current conditions: Storefront has been altered with partial non-historic infill.

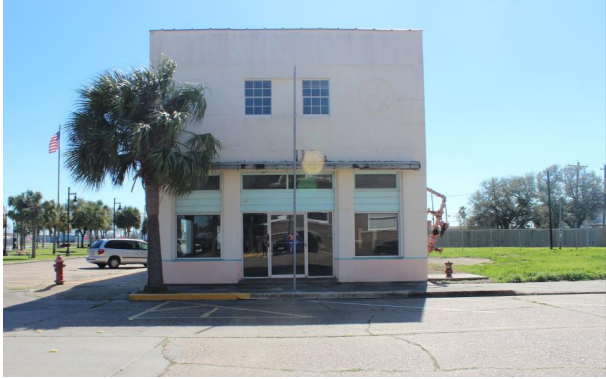
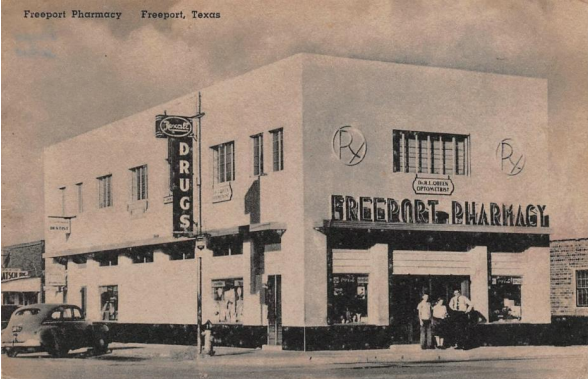
Historic function: Originally constructed as a one-story building for the Freeport National Bank. A second story was added in 1915 to house the Houston & Brazos Valley Railway offices. A two-story addition was built on the adjoining lot in 1918. In the 1940s, it housed Freeport City Hall and the Chamber of Commerce meeting room (1943 Sanborn). The Freeport Sulphur Company bought the building in 1955 and housed its offices there until 1973.
Current function: Park Ave. Lofts
Current conditions: Historically iron bars were located on the first floor bank windows; they have been removed. The building has otherwise experienced minimal change to the exterior.

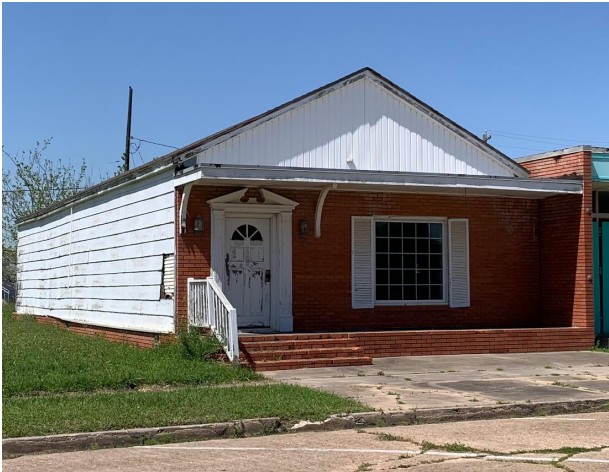
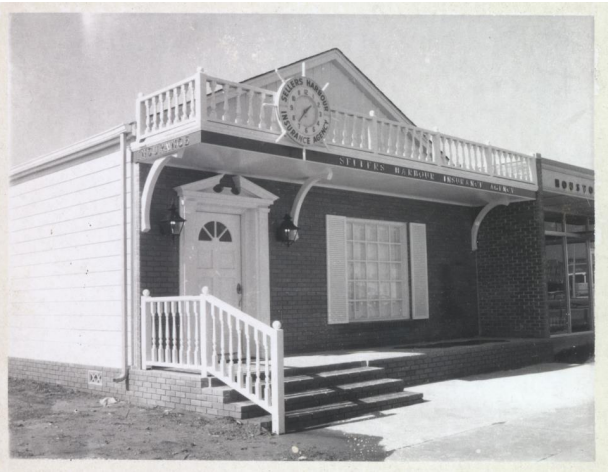
Historic function: Constructed as the Brazosport office of the Houston Natural Gas Company, which operated in the building until at least the early 1970s. The brick building included a covered drive-in window for customers and a small paved parking area. As a “nostalgic touch” a gas light burned 24 hours a day on the front of the building.
Architect: the Austin Company.
Current function: Vacant
Current conditions: The glass storefront windows have been covered with painted plywood, but appear to be intact beneath. Minimal alterations beyond the removal of original Houston Natural Gas Company signage.

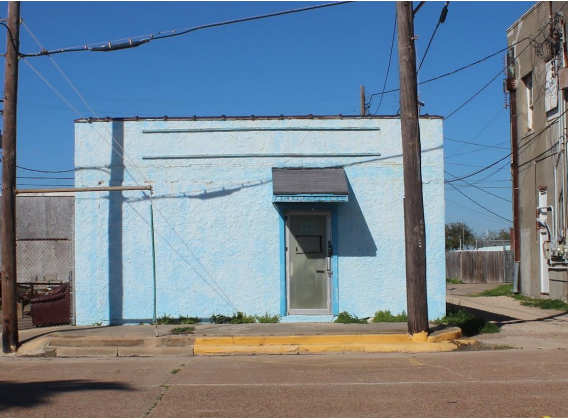
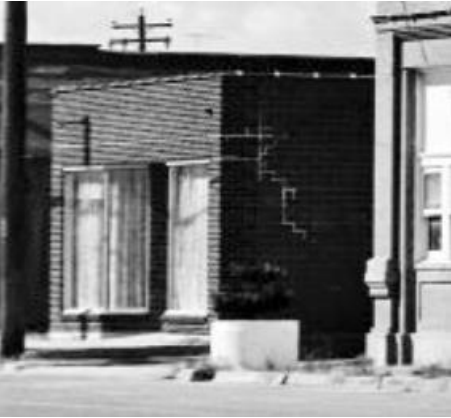
Historic function: Constructed by a Mrs. W.L. Water and identified as the “Walter Building” in some newspapers. Occupied by Sellers Insurance Agency (later Sellers Harbour Insurance Agency) from 1945 until the 1970s.
Current function: Vacant
Current conditions: The railing along the awning has been removed.

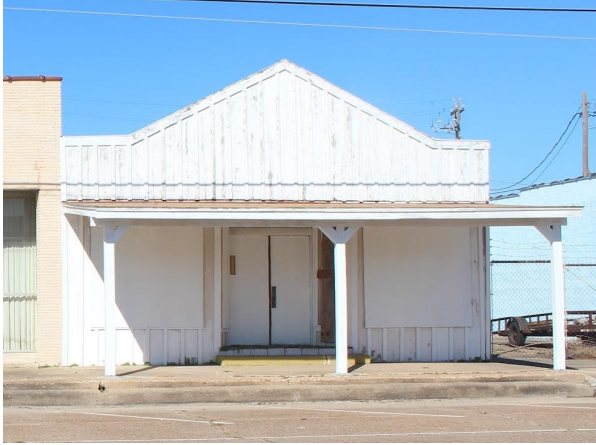
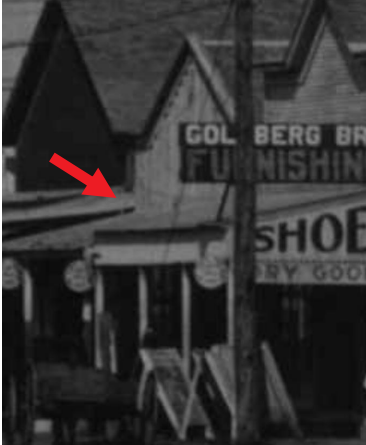
Historic function: Constructed for Gary Hardware & Sporting Goods. During the 1960s it housed Landry Hardware and the Retail Merchants Association, and the Credit Bureau of Freeport from the late 1960s into the 1970s.
Current function: Vacant
Current conditions: Original storefront has been infilled and is no longer discernible. Brick has been coated with stucco.

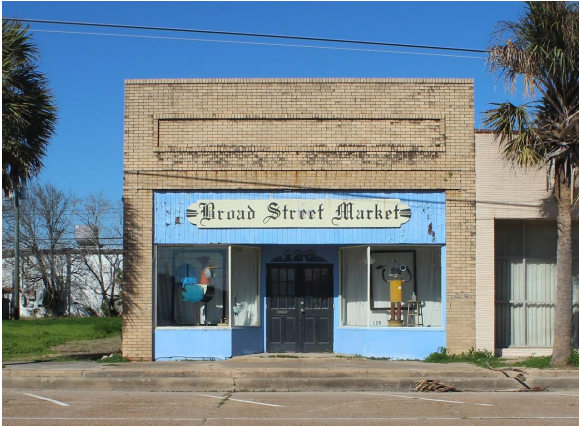
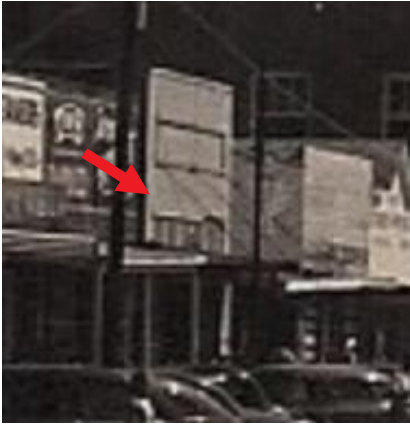
Current conditions: Appears to have been minimally altered beyond painted brick. Front door is covered but appears to be original.

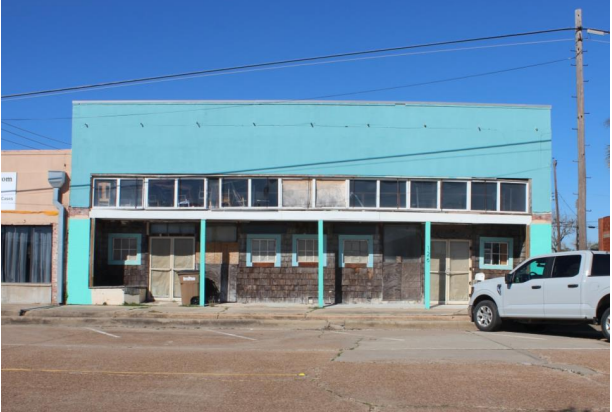
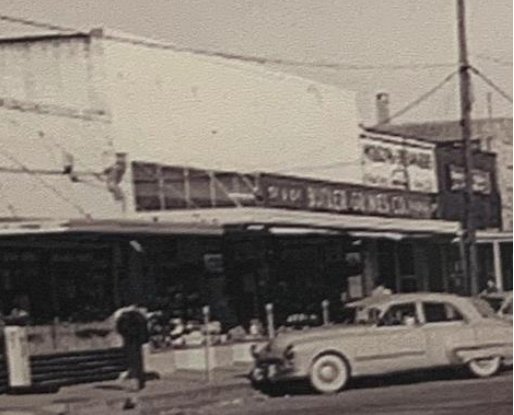
Current conditions: Awning has been removed and transom is boarded.

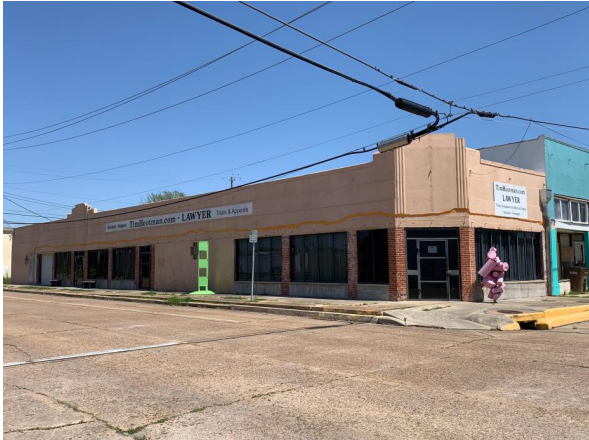
Current conditions: Storefront has been removed, creating open recessed space beneath the second story. Shingles and non-historic windows applied to primary elevation. Awning has been removed.

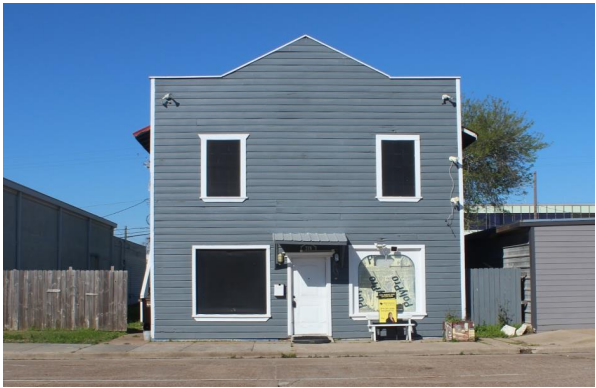
<p>CURRENT PHOTO</p>

Historic function: Ben Gordon Loans first known occupant (1954-1962). Ward's Fashion Outlet in the early 1970s. West addition was added some time prior to 1982.
Current function: Residence
Current conditions: Though no clear historic photos have been found, the primary facade has been altered through the removal of the historic storefront and application of vinyl siding.

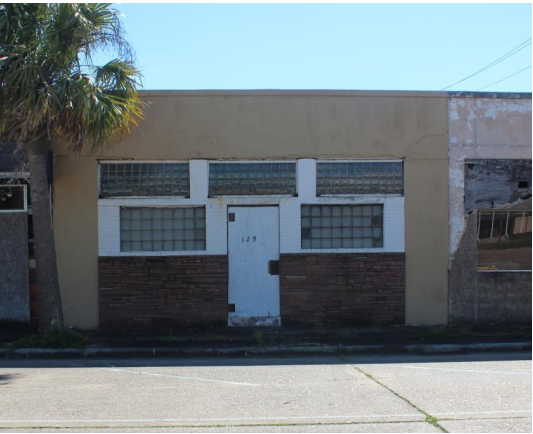
CURRENT PHOTO

Current conditions: Non-historic aggregate concrete cladding is in deteriorated condition, revealing historic stucco exterior beneath. Original openings have been partially infilled and altered.

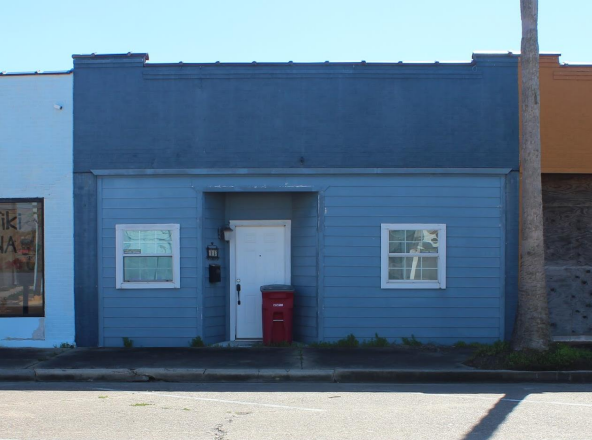
CURRENT PHOTO

Historic function: Part of a block of three buildings constructed by Nannie Maddox Stringfellow. McSpadden Jewelry was the original occupant and remained in the building until 1961. It was then occupied by the Brazosport Flower Shop until at least the early 1970s.
Current function: Vacant
Current conditions: Brick facade has been painted. Storefront is boarded, but appears to be intact beneath.

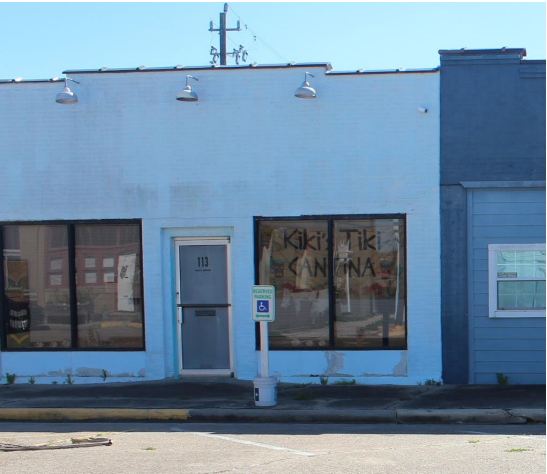
CURRENT PHOTO

Historic function: Part of a block of three buildings constructed by Nannie Maddox Stringfellow. Emerald Beauty Shop was the original occupant and remained there until at least the early 1970s.
Current function: Residence
Current conditions: Brick facade has been painted. Storefront has been infilled and heavily modified: if a more compatible storefront were introduced, the building could be changed to contributing status.

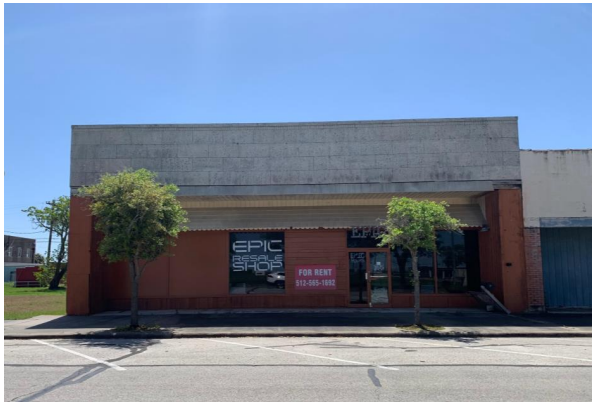
CURRENT PHOTO

Historic function: Part of a block of three buildings constructed by Nannie Maddox Stringfellow. Frenchy's Barber Shop was the original occupant.
Current function: Vacant
Current conditions: Exterior brick has been painted. Newer, compatible storefront has been installed.

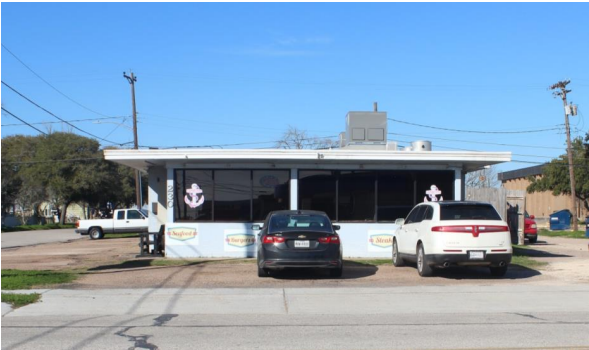
<p>CURRENT PHOTO</p>

Historic function: Built and operated as a Goodyear Service Store until at least the mid-1970s.
Current function: Signal Electronics
Current conditions: Historic storefront has been heavily altered with non-historic infill.

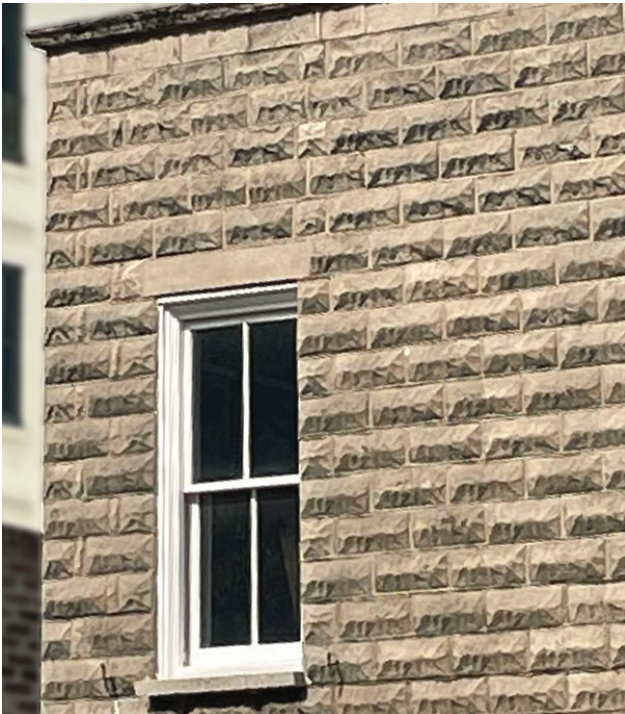
Figure 2a. Casting concrete blocks to mimic quarried stone was a popular late 19th- to mid 20th-century technique. Concrete masonry units could be completed by local craftsman, saving time and shipping costs. Photo: John Sandor, NPS.

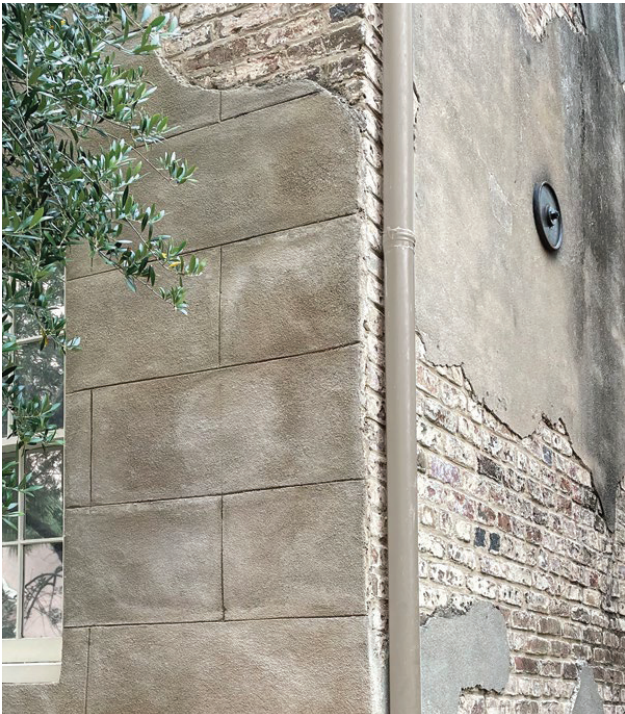
Figure 2c: Stucco has been used to imitate a number of building materials for many centuries. Seen here, stucco was applied to a brick structure and scored to represent a stone façade. Photo: John Sandor, NPS.

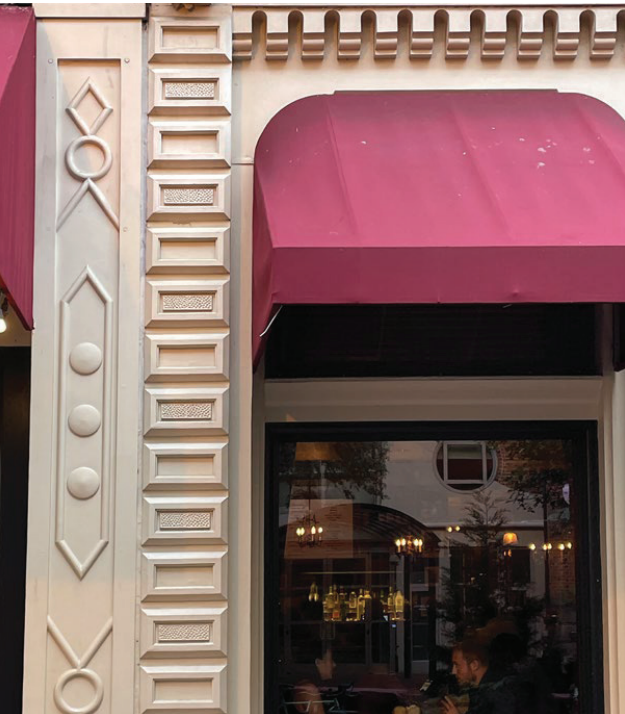
Figure 2b: The 19th century also produced a variety of metal products used to imitate other materials. Across the country, cast iron was used in storefronts to imitate stone. Photo: John Sandor, NPS.

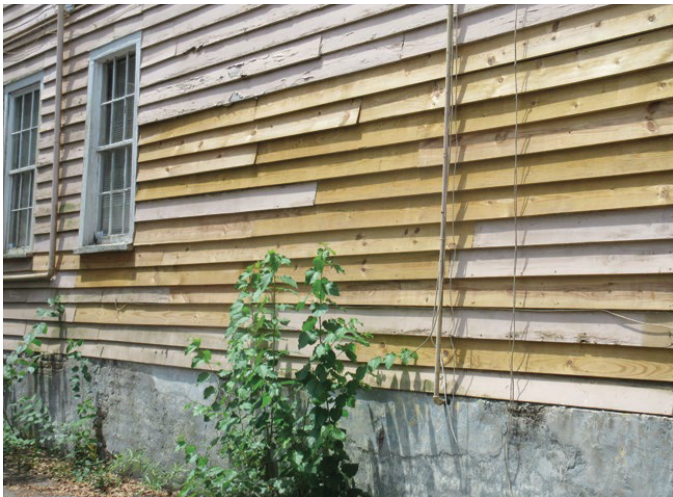
Figure 3: Incremental repair is best done using in-kind material to minimize differences in the performance characteristics that could negatively affect the overall assembly. Photo: NPS.

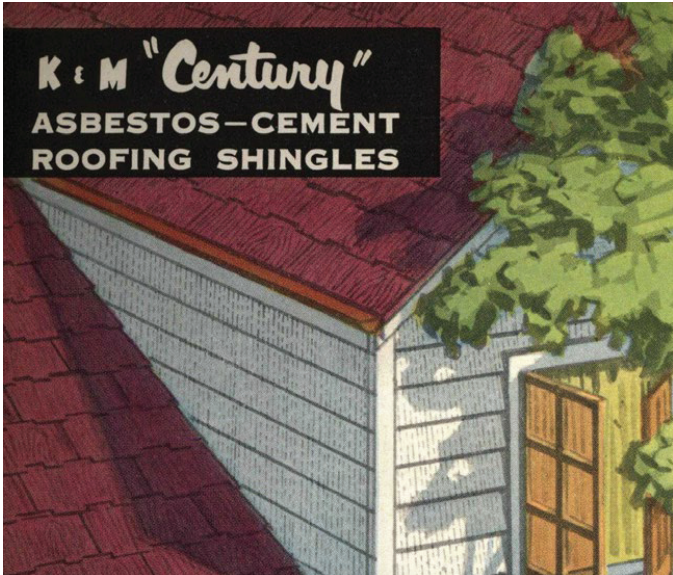
Figure 4. While occasionally used to imitate other materials such as wood or slate shingle, many asbestos shingles and siding materials had their own distinct shape and profile. No longer manufactured today, alternative materials must be found to replace these materials when they are distinctive features on a historic structure. Drawing: Association for Preservation Technology, Building Technology Heritage Library.

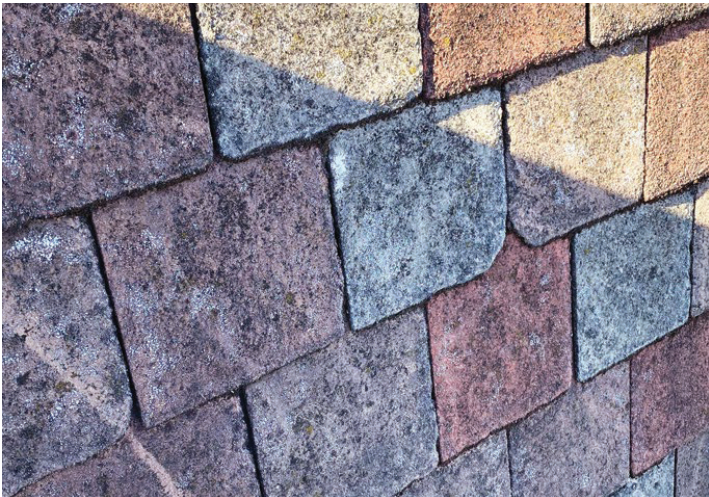
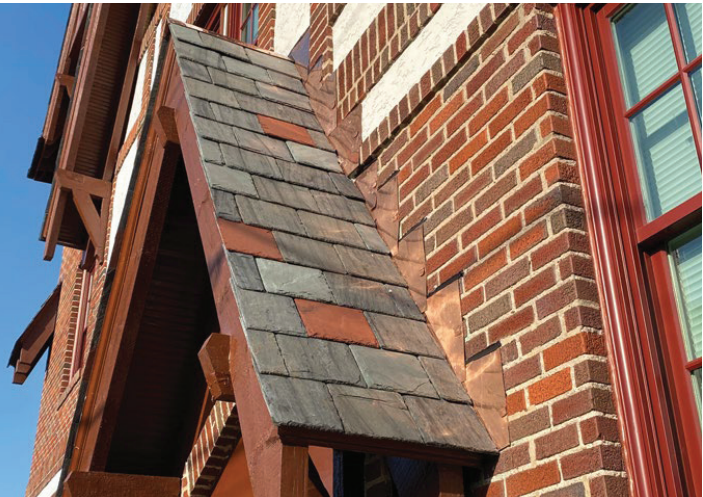
Figure 5. (Left) Asbestos shingles were often used as a substitute for traditional slate roof shingles. The historic asbestos roof on this rehabilitation project had reached the end of its lifespan and required complete replacement. (Right) Given the limited replacement materials available to match the historic asbestos shingles, utilizing natural slate was determined to be the best visual match for the original shingles and design intent in this instance. Photos: Crosskey Architects.

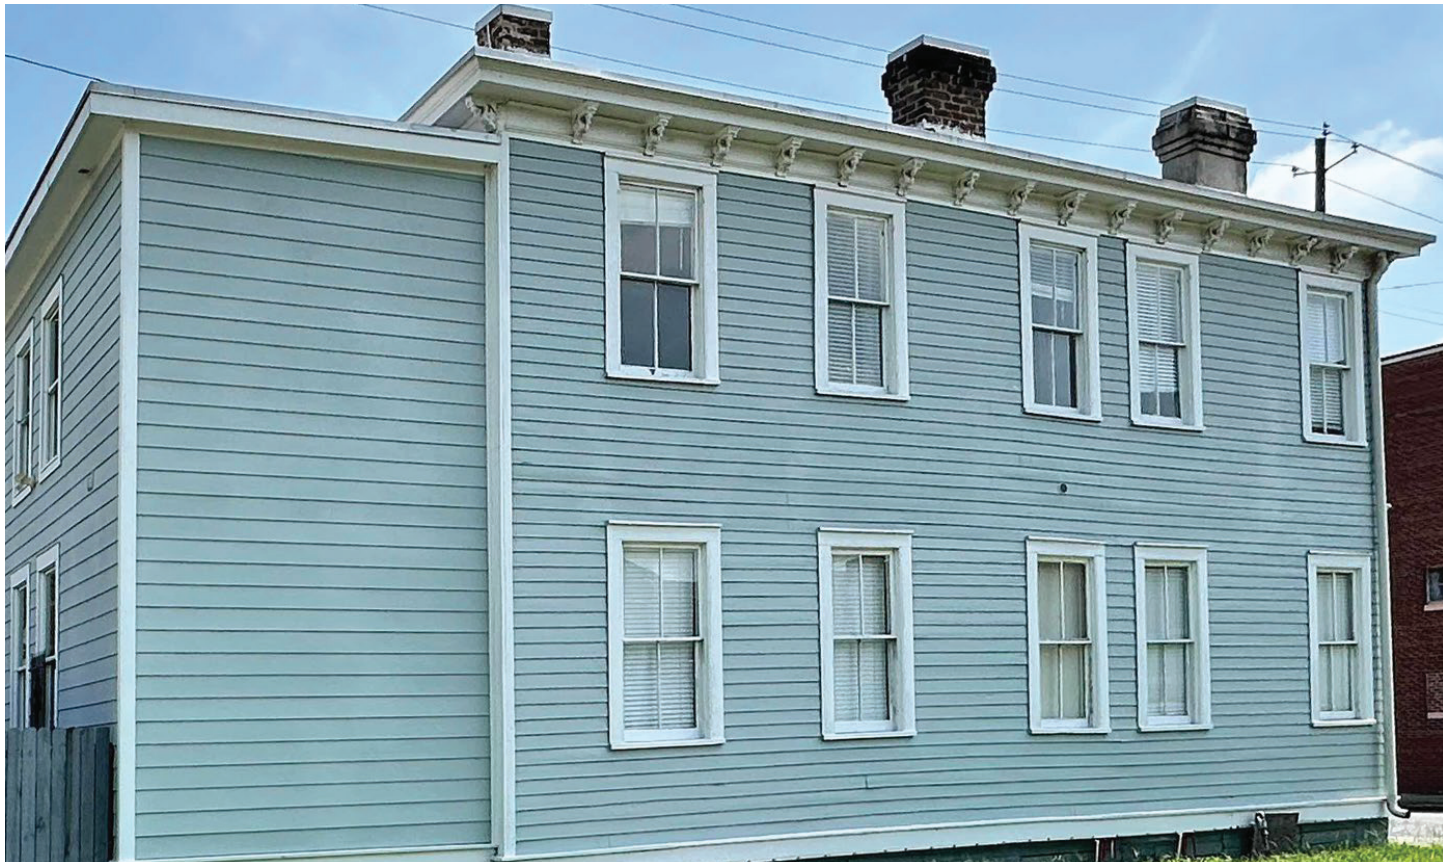
Figure 7. A new addition replaced non-historic construction on the rear elevation of this building. Fiber cement gives the addition a compatible appearance without replicating the exposure for thickness of the historic siding. Photo: Ward Architecture + Preservation.
