Downtown Historic District Design Guidelines City of Freeport, Texas

Prepared by Post Oak Preservation Solutions &
University of Texas at San Antonio Center for Urban and Regional Planning Research
October 17, 2024

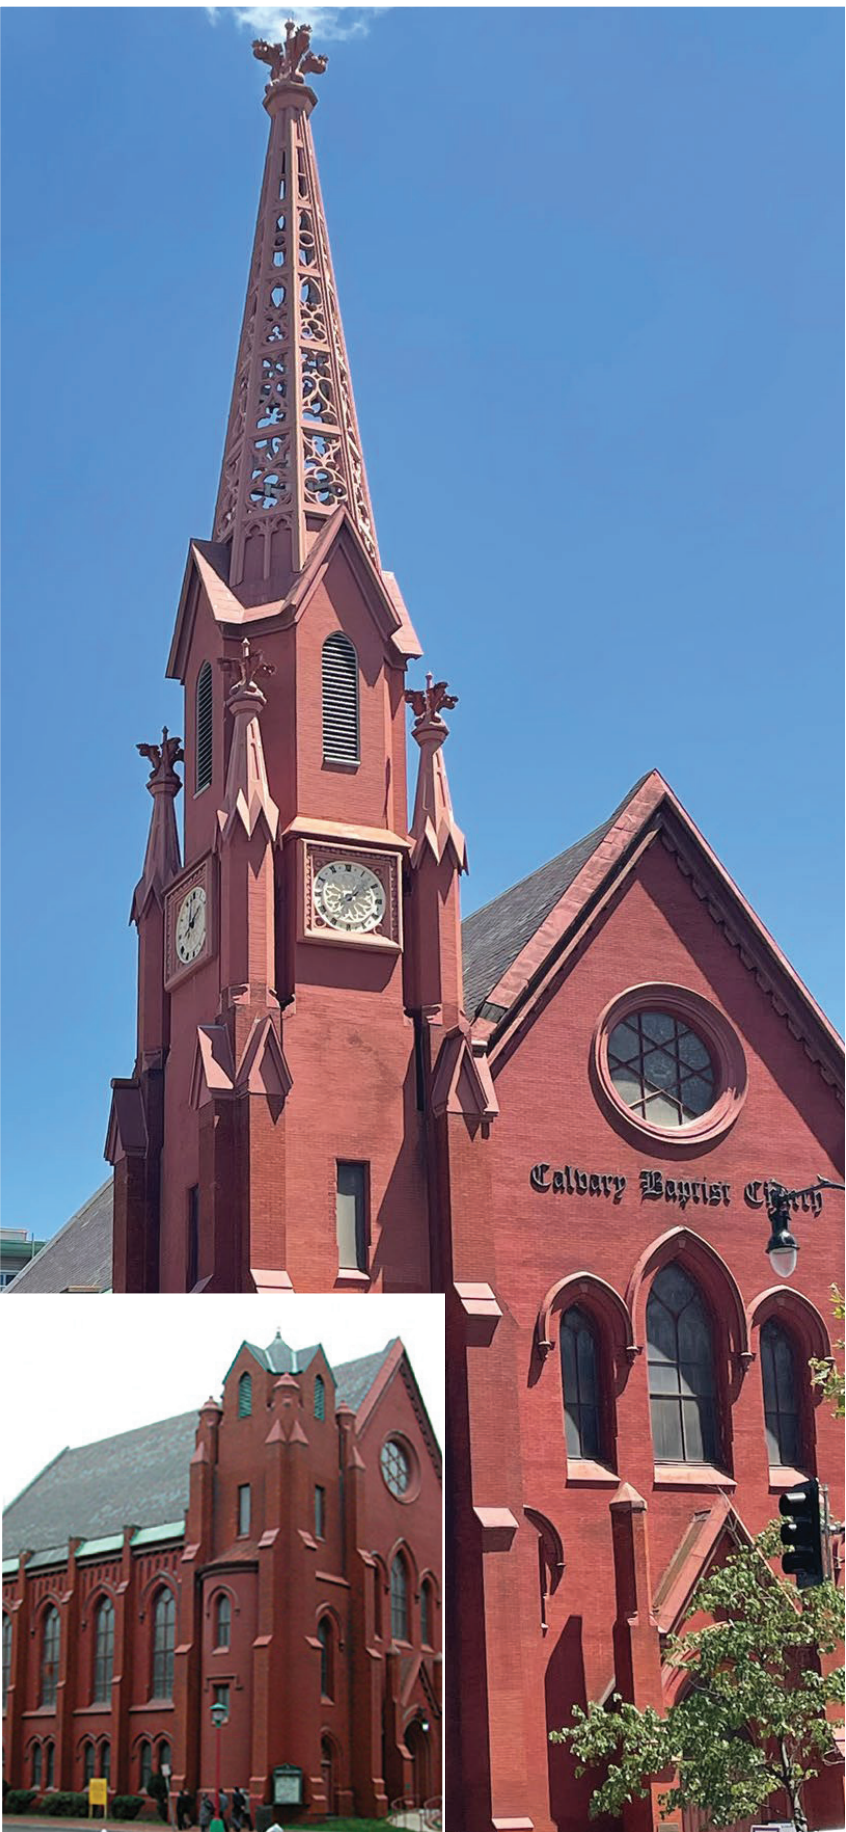
Figure 8. A long-missing cast-iron steeple was reconstructed in aluminum and fiber-reinforced polymer (FRP). Photo: John Sandor, NPS, Inset: Quinn Evans.

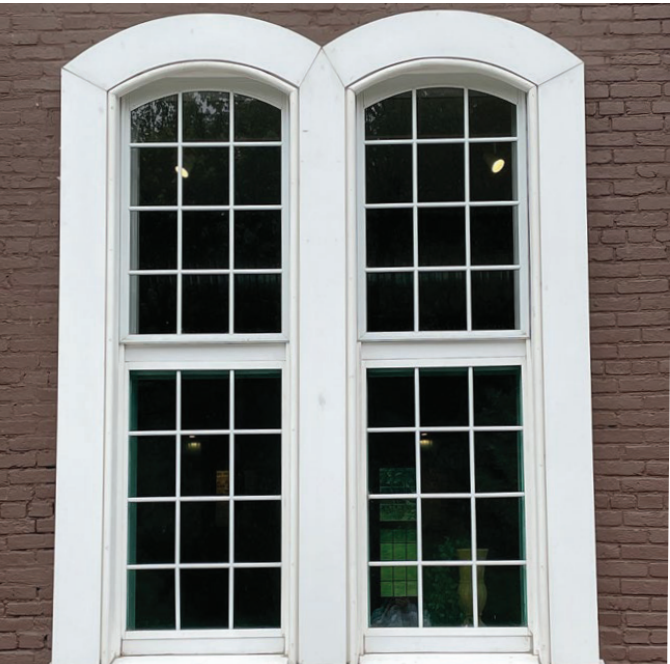
Figure 9. Previously bricked-in openings below the flood line were reopened and new aluminum windows installed with cellular PVC trim detailed to hold back moderate flood waters and survive exposure to water. Photo: John Sandor, NPS.

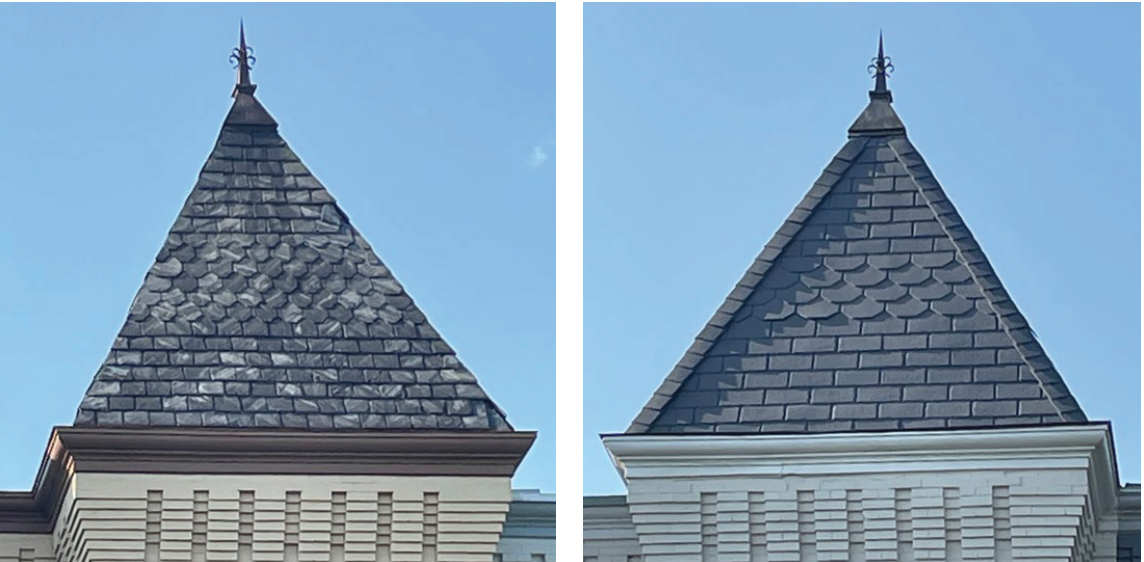
Figure 10. Polymer slates offer a choice of shapes but not sizes, limiting their ability to achieve a good visual match for some historic slate. With the size of the polymer slates (right) being nearly twice that of the historic slates (left), the scale of the entire feature is incompatibly altered. The molded edges of this material, which contribute to its ability to replicate slate, would be lost if each shingle was resized by cutting. Photo: John Sandor, NPS.

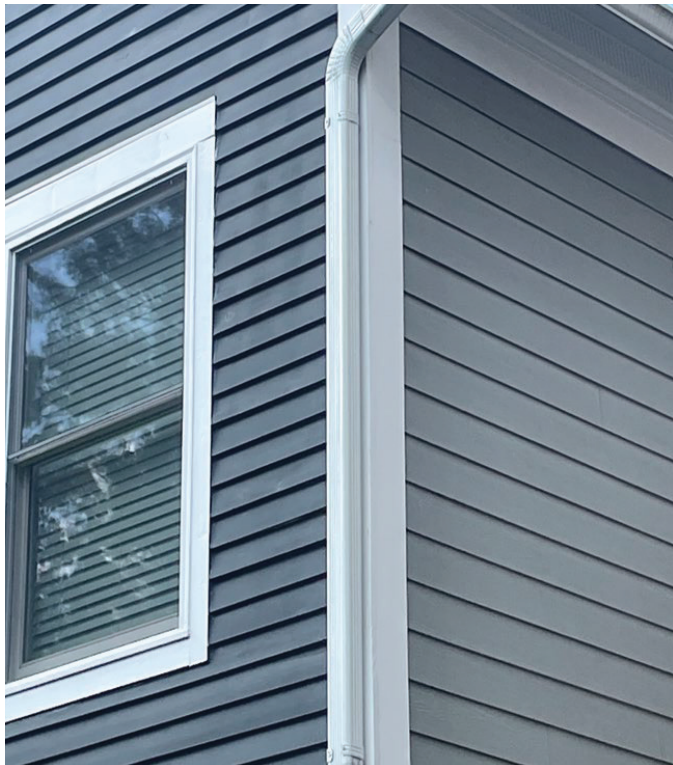
Figure 11. The thickness of the wood siding on the front (left) creates a deeper shadow line than is achieved with the fiber cement siding used on the side (right) elevation. While the exposure can be adjusted, fiber cement siding is not available in a matching thickness. Photo: John Sandor, NPS.

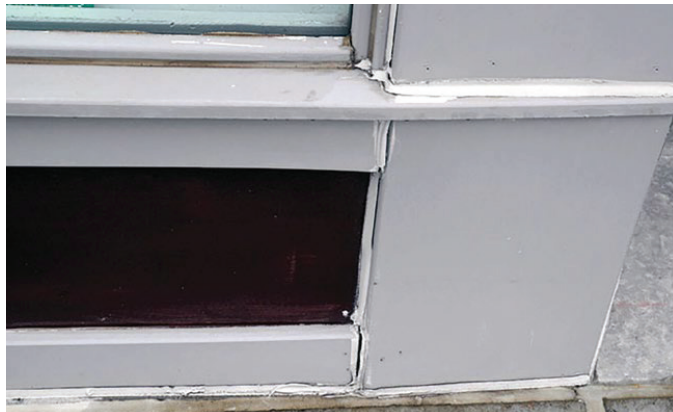
Figure 12. Cellulose composite materials, like wood, expand and contract with moisture. Here it was used to reconstruct a missing storefront. Unlike solid wood that is dimensionally stable parallel to the grain, this composite moves equally in all dimensions, resulting in gaps that were not adequately anticipated in the design. Photo: John Sandor, NPS.

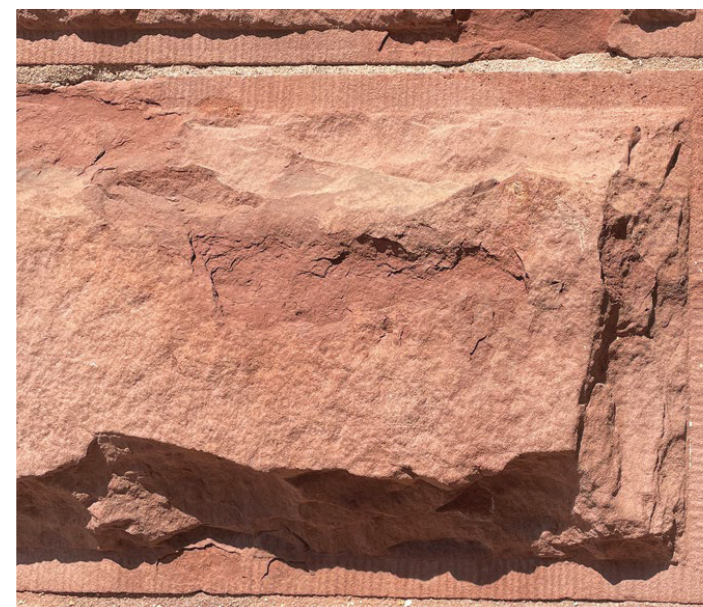
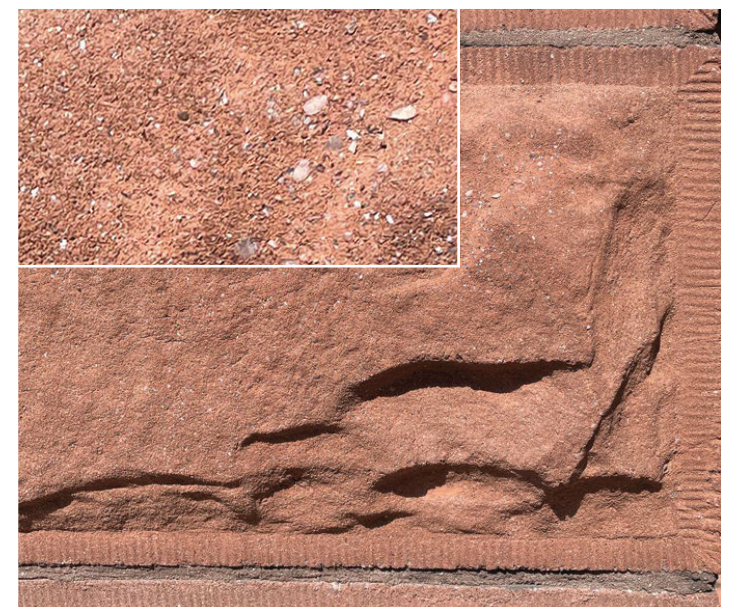
Figure 13. Cast stone was used to effectively replace individual blocks of sandstone. Both the original (left) and the substitute material (right) retain similar physical and visible properties. Having weathered for over 30 years, some erosion of the binder has revealed quartz grains of the aggregate (inset), but it is only noticeable upon close inspection. Photo: John Sandor, NPS.

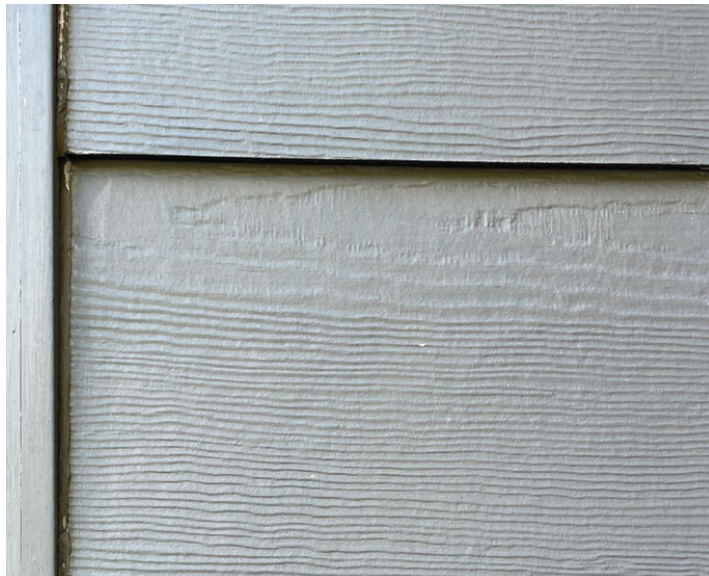
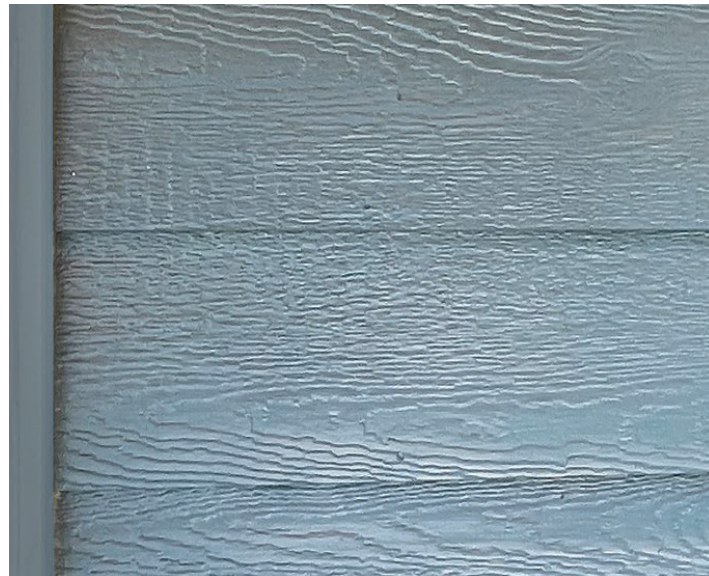
Figure 14. Surface texture is an important aspect in matching the appearance of a historic material, especially when a material is viewed at close range. As seen in these two images, many of the substitute materials produced for siding and trim have an embossed wood grain, making them incompatible for replacing historic wood that was typically planed to a smooth surface. Some substitute products are available with a smooth surface as well. Photos: John Sandor, NPS.

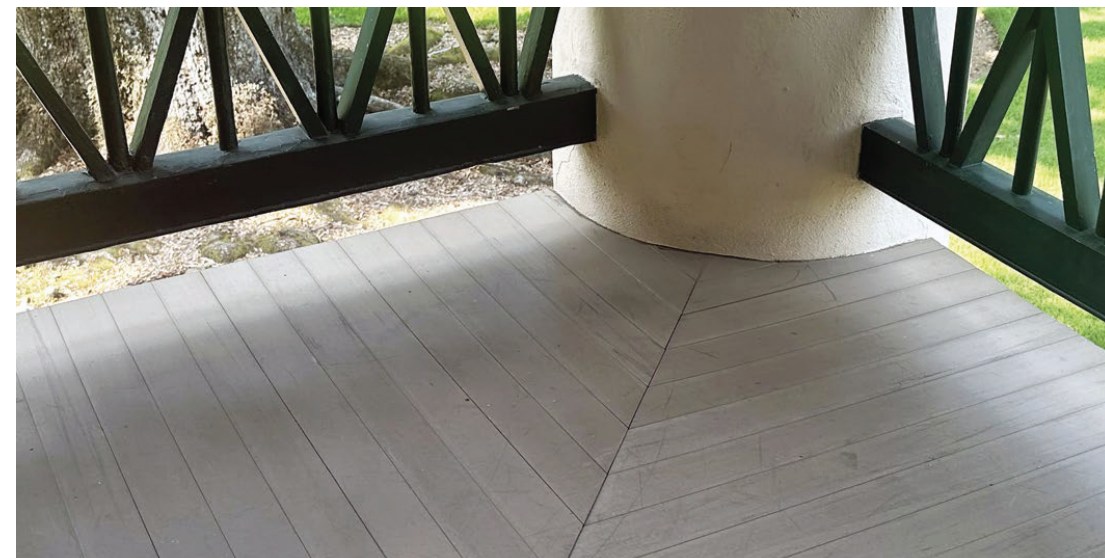
Figure 15. Tongue-and-groove porch flooring is manufactured in several different substitute materials. Each type has different properties, though most are more moisture-resistant than wood. The prefinished product shown can be painted when worn, but repainting is not recommended for some product choices. Photo: Oak Alley Foundation.

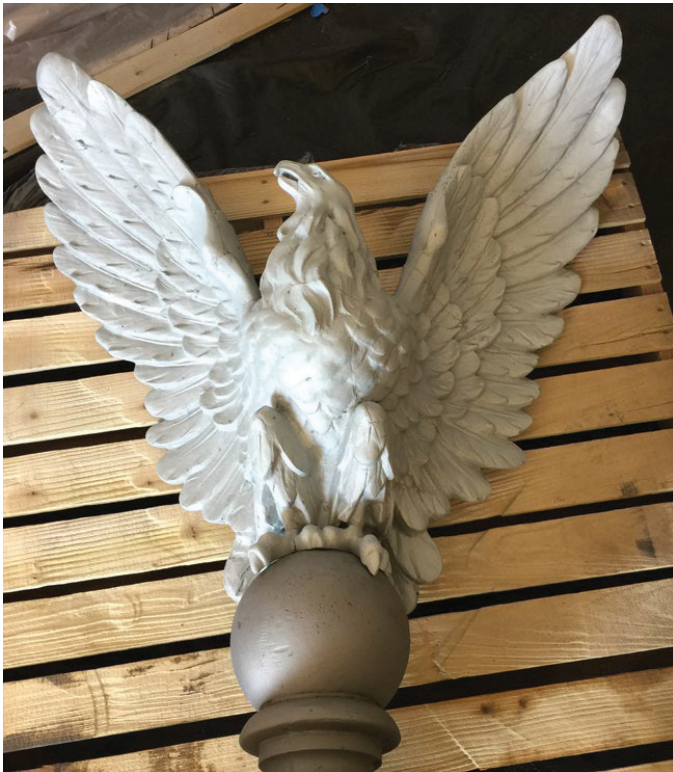
Figure 16. Aluminum is a highly corrosion-resistant metal that is commonly used as a substitute material for cast iron. Aluminum can be a more affordable and lightweight alternative to cast iron that retains a similar texture, shape, and maintenance cycle. Photo: NPS.

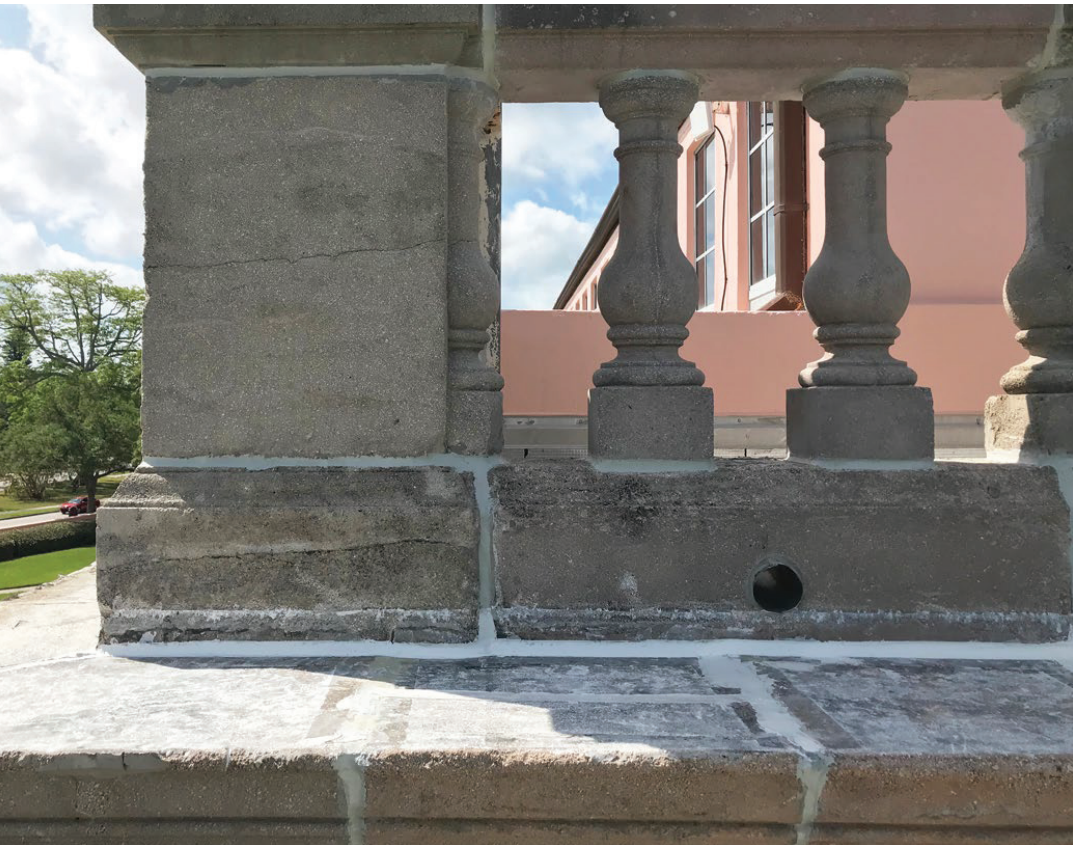
Figure 17. The balustrade consists of multiple prior campaigns of using cast stone to replace the natural stone. The effective match for the surface texture and color of the original stone allowed individual elements to be incrementally replaced only when they had failed, thus retaining the maximum amount of original material as long as possible. Photo: EverGreene Architectural Arts.

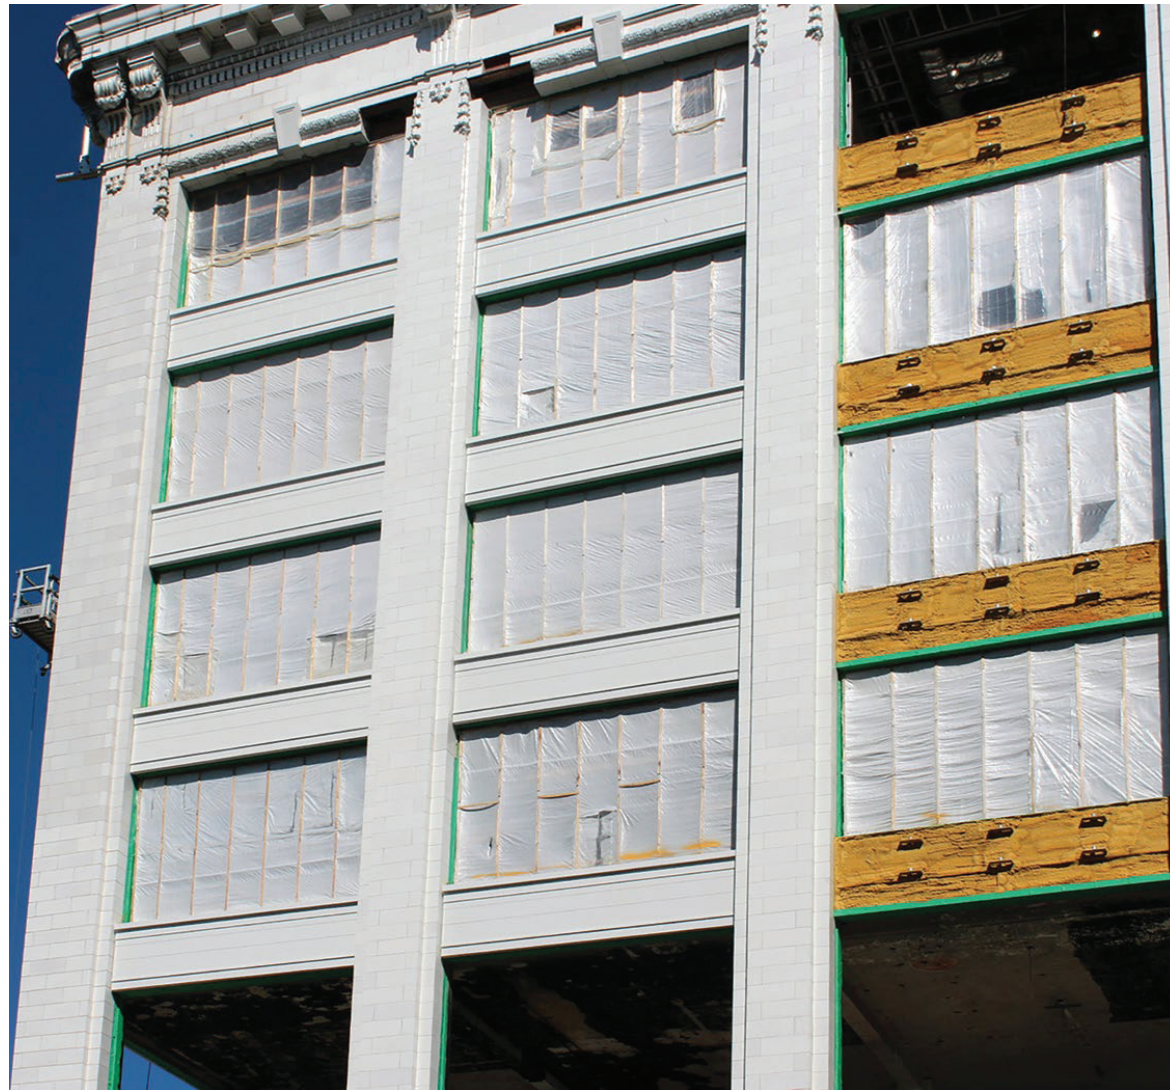
Figure 18. Missing historic terra cotta spandrel panels on all floor levels were recreated utilizing glass fiber reinforced concrete (GFRC) replacements. New spandrels were fabricated as individual components and attached with metal clips between historic terra cotta piers. Photo: Kris Frail, Dewberry.

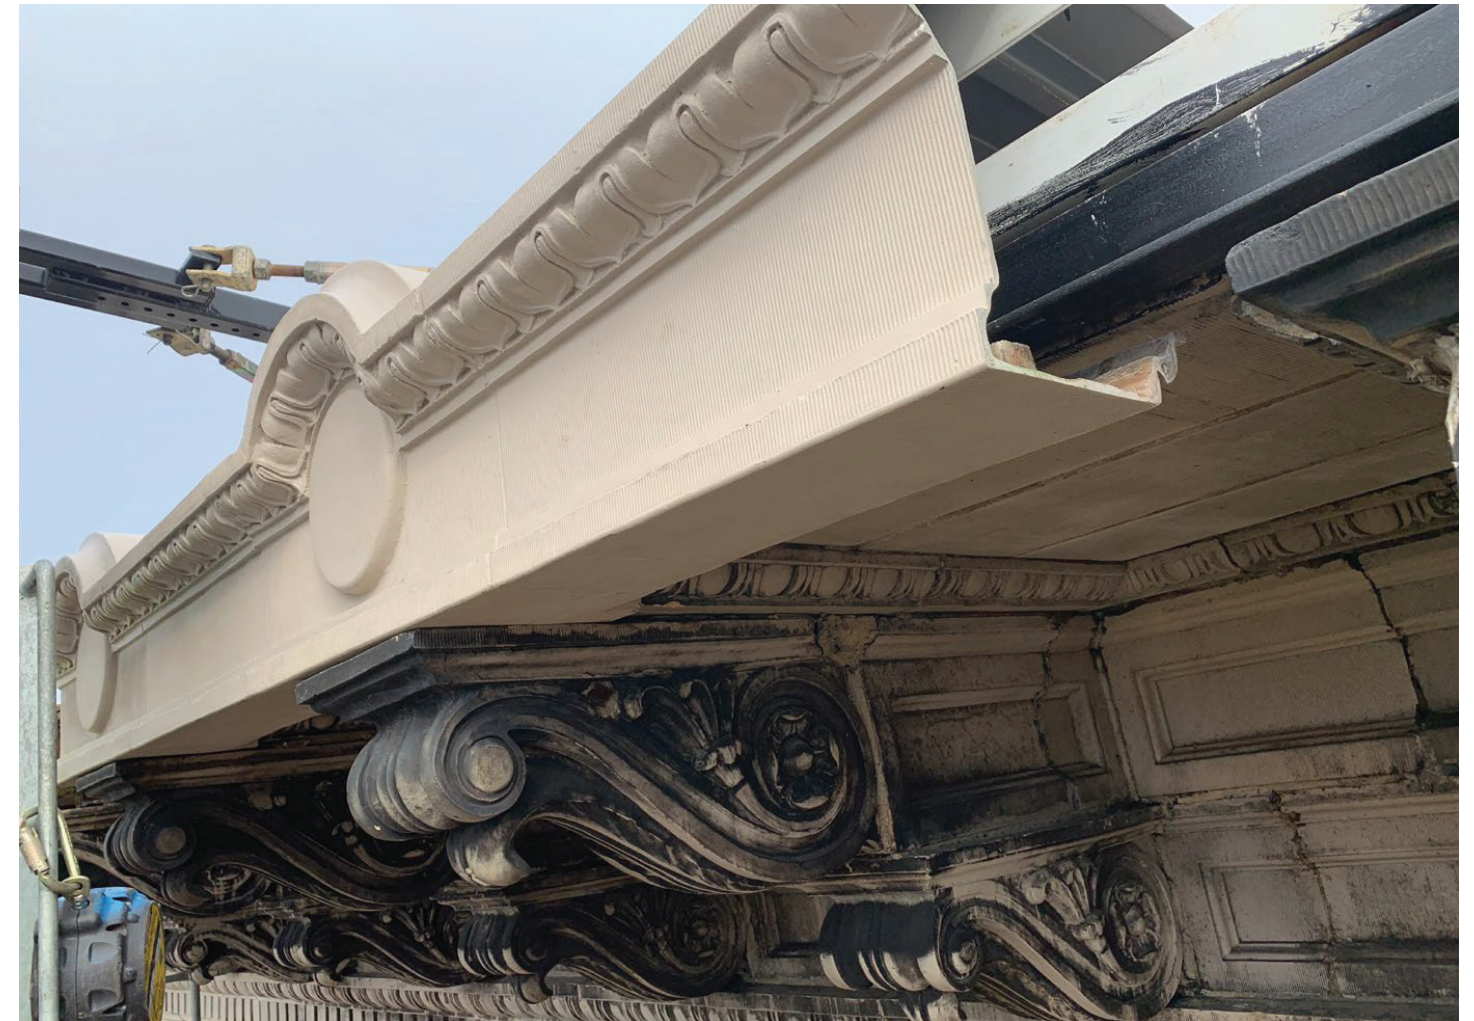
Figure 19. A new, lightweight fiber reinforced polymer is attached to a new metal armature to replicate damaged and missing elements of a terra cotta cornice. Photo: Quinn Evans.

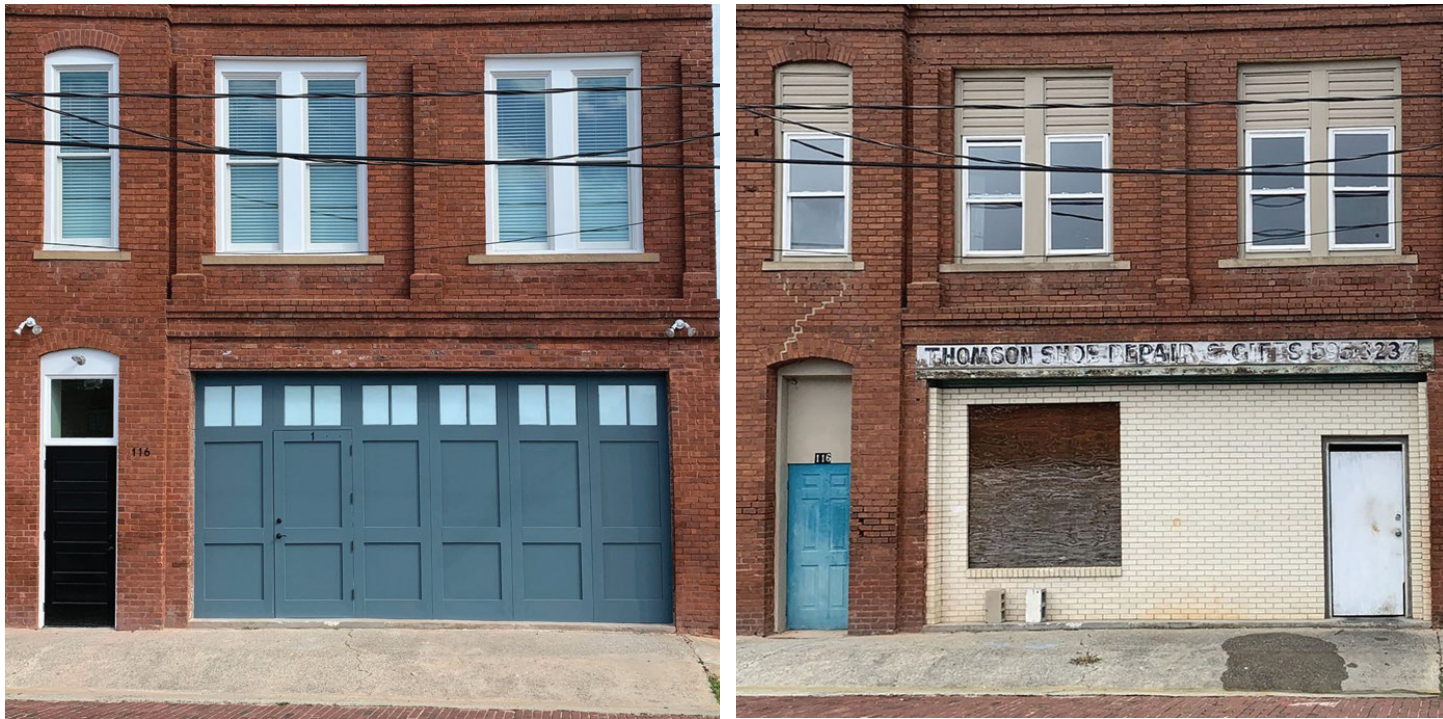
Figure 20. Cement board was used to replace a non-historic infill and mimics the configuration of a typical vehicular door of the period.
Photos: Historic Augusta.

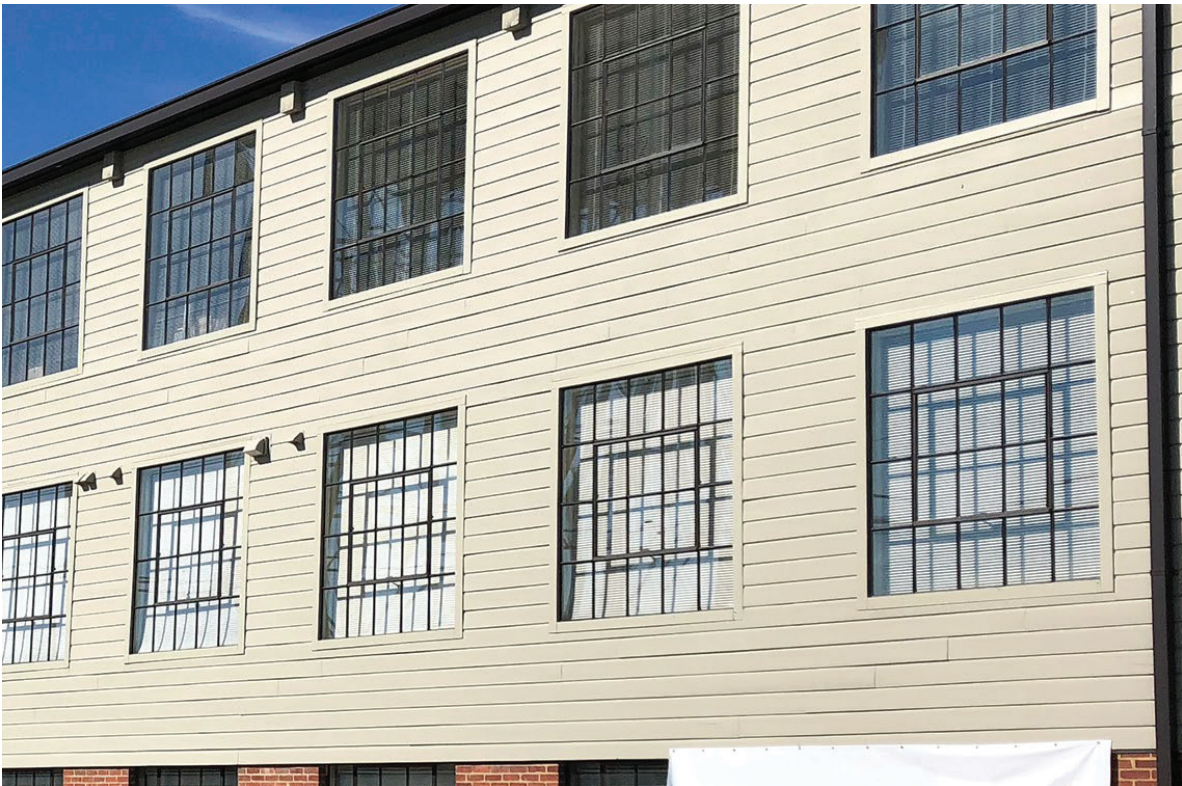
Figure 21. A mineral polymer composite siding was available in the profile very similar to the historic siding. The replacement siding was used where the original material was almost completely missing beneath a more modern covering. Areas where the original wood was largely intact were replaced with matching wood to sustain more of the material integrity of the building. Photo: Belk Architecture.

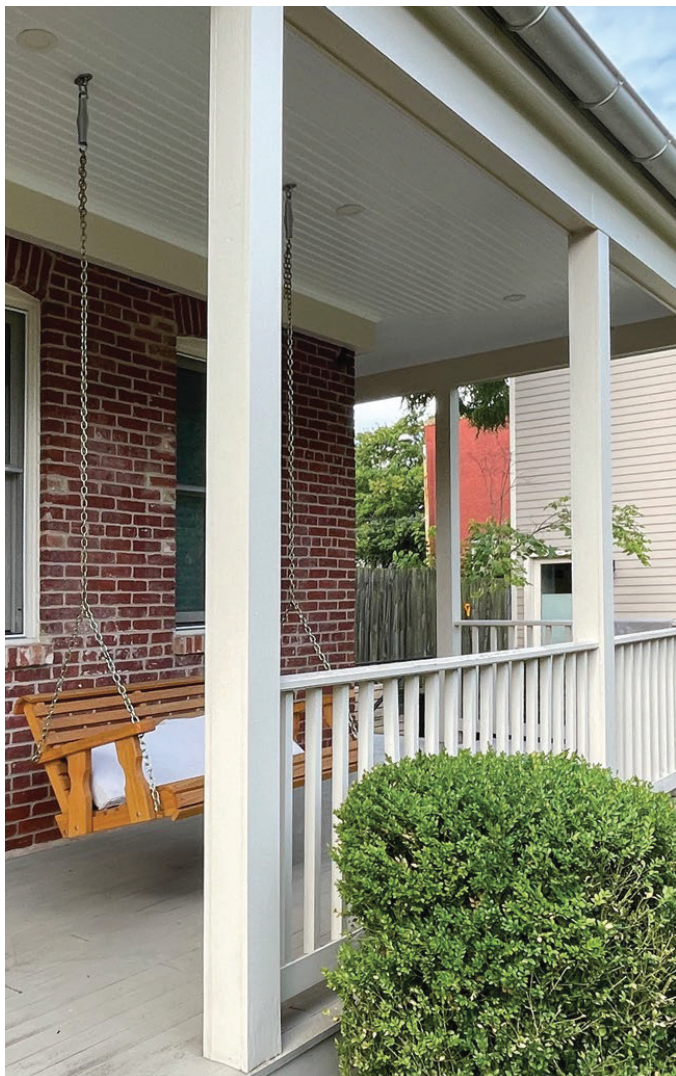
Figure 22. A porch was reconstructed using posts fabricated on site from a smooth-surface cellulose/polymer composite material. Though the face of the posts are painted, the lack of paint on the bottom at the cut ends is not consistent with manufacturers' recommendations. This treatment will allow moisture to be absorbed, shortening the life of the new replacement feature. Photo: John Sandor, NPS.

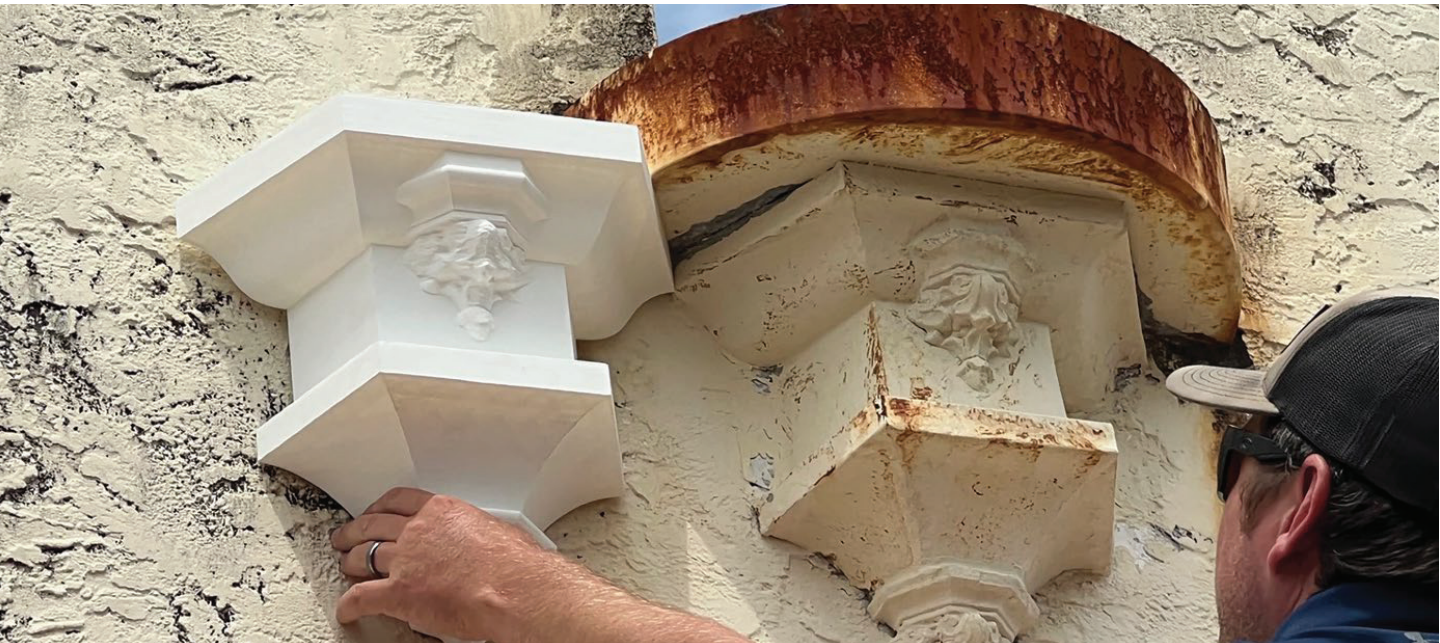
Figure 23. 3-D printing using various polymers is occasionally used to replicate missing metal or wood features. This new application is continually being refined, but the application can be successful when a painted, lightweight feature needs to be replicated. Photo: NPS.

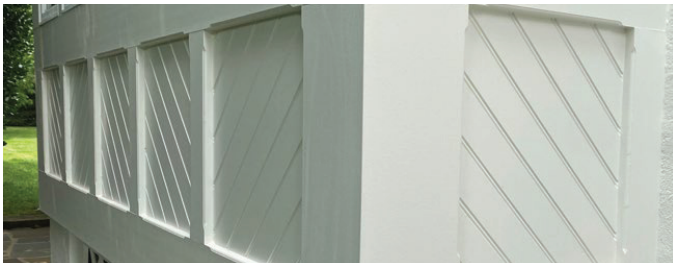
Figure 24. Cellular PVC when painted can be used to replace deteriorated wood features. This beadboard set in a wood frame was not historically designed to shed water effectively and had deteriorated. Cellular PVC was able to match the appearance of the wood details, while its properties were well matched to the shady location, painted finish, and limited size and configuration within the overall assembly; thus, it should provide a long-lasting solution for this application. Photo: Jennifer Balson Alvarez, NPS.

- Isotropic
- Lighter and more flexible than wood
- Less strong than wood (in tension and shear), but can span typical floor- framing spacing as decking
- More impact-resistance than wood
- Negligible water absorption; no moisture-driven movement, unlike wood
- Subject to thermal expansion and contraction significantly greater than wood, though the thermal movement is less for the same dimension than the cross-grain moisture-driven movement of wood

- For longer pieces, thermal movement requires manufacturer’s specifications to be followed for attachment, and inclusion of expansion joints when installed at low temperature (joints should be glued)
- Class A flame spread
- Resists insect damage
- Machinable with woodworking tools, though cut edges may need additional surface prep for finish
- Good paint adhesion; if painted, high light reflectance (HLV) is recommended to minimize heat driven expansion
- 25–30-year limited warranty, depending on manufacturer
